# MEMORANDUM

TO:	Clutha District Council	Job No.:	000873
ATTENTION:	Jules Witt	Date:	20 December 2024
FROM:	Melanie Stevenson	Page 1 of 13	
SUBJECT:	Hospital Creek Flooding 2 <sup>nd</sup> - 5 <sup>th</sup> October 2024 - Review	Reference:	MEMO 24-12-20 MKS 000873

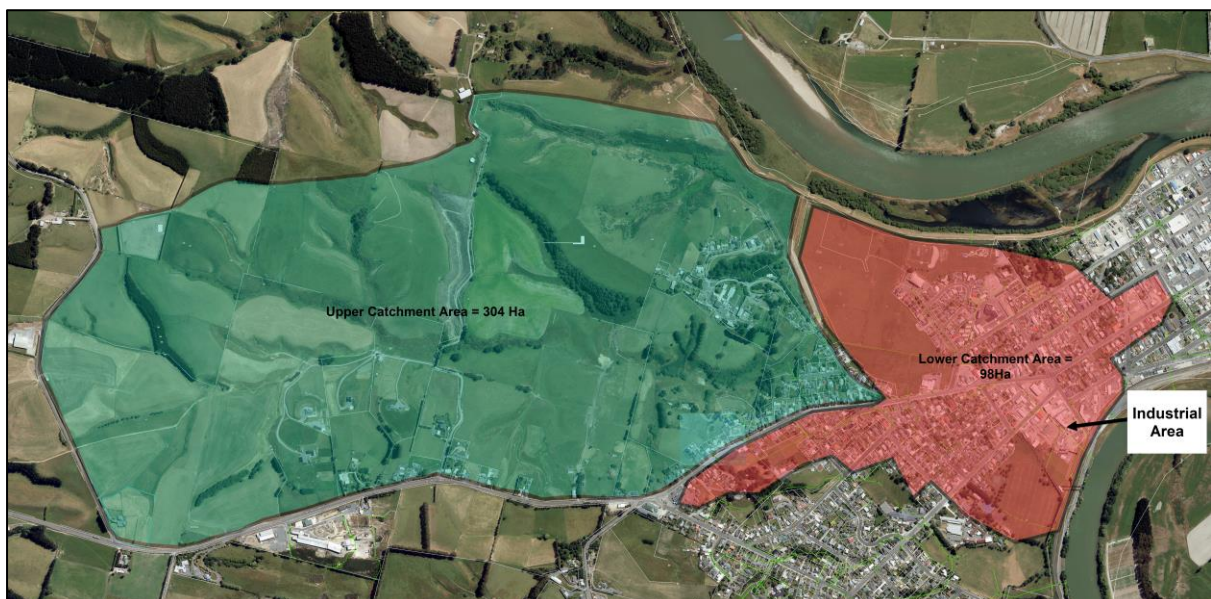
**Figure 2.1: Hospital Creek Stormwater Catchment**

The Hospital Creek Stormwater system drains a 402Ha catchment area comprising of:

- Upper Catchment - 304 Ha rural catchment area
- Lower catchment - 98 Ha urban catchment area.

The catchment area is shown in Figure 2.1 below.

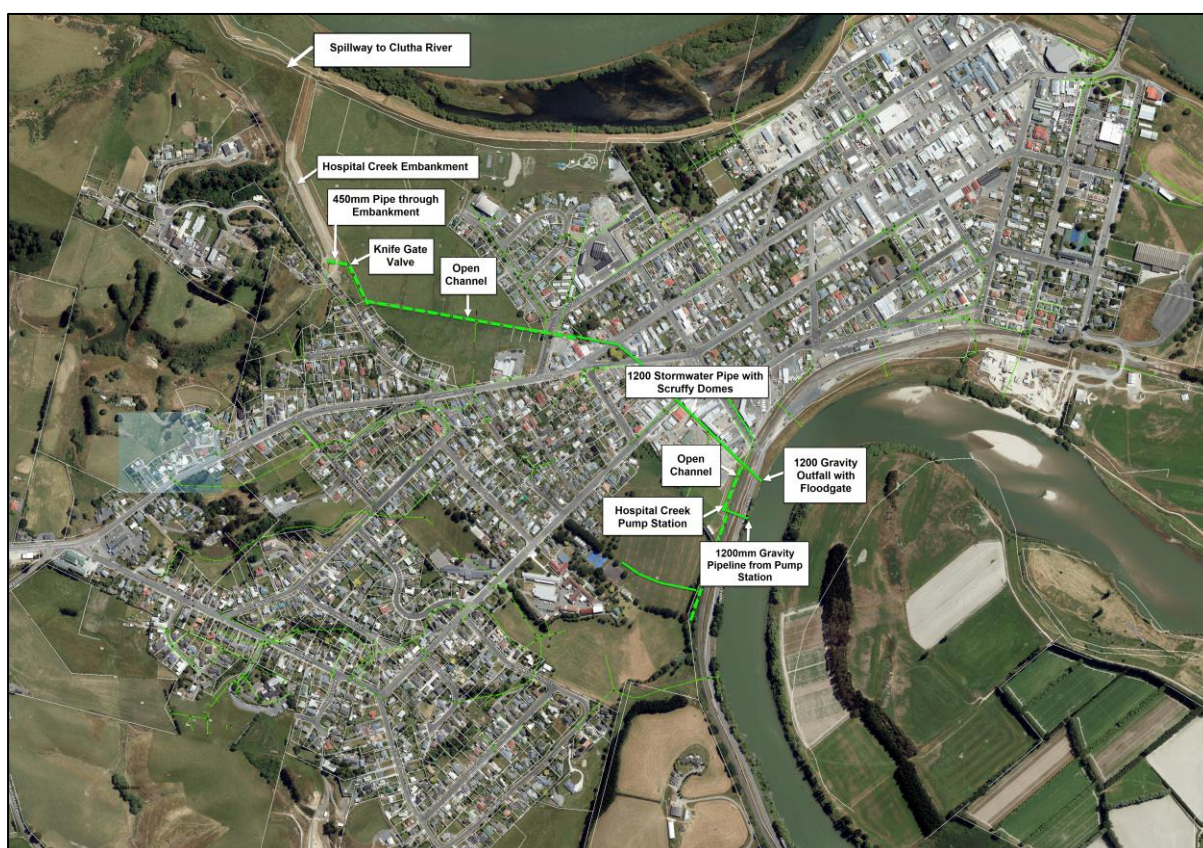
Figure 2.2: Hospital Creek Stormwater System

Figure 2.2 shows the layout of the Hospital Creek Stormwater system.

Stormwater runoff flows from the upper rural catchment area are attenuated within the Hospital Creek Detention Basin.

Downstream of the detention embankment, Hospital Creek is conveyed via an open channel through flat farmland before entering a 1200mm diameter pipeline.

The pipeline discharges to an open channel near the Clutha River before either being gravity piped through to the Clutha River or pumped to the Clutha River, via the Hospital Creek Pump Station.

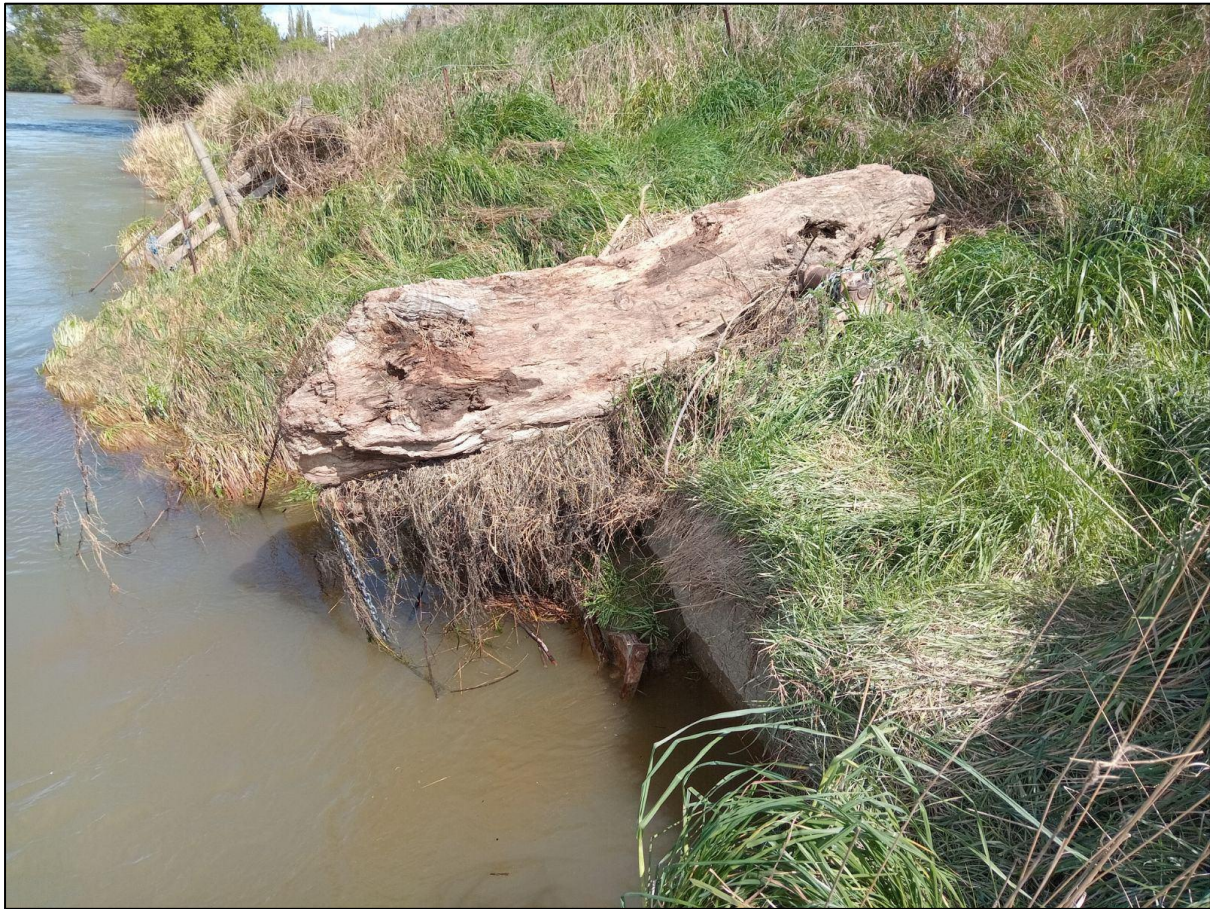
**Figure 2.3: Log on Flood gate at Gravity Discharge**

Following the October 2024 event, a log was found on top of the chain that may have been causing the gate to not be fully closed. See Figure 2.3 below.

Survey information confirms that the flood level during the October event was around 1.6m above the flood gate which would have been high enough to shift the log into this position.

- Ensure the chain on flood gate on gravity discharge pipe allows the gate to completely lower with a further allowance for slack - to ensure logs cannot hold gate open.

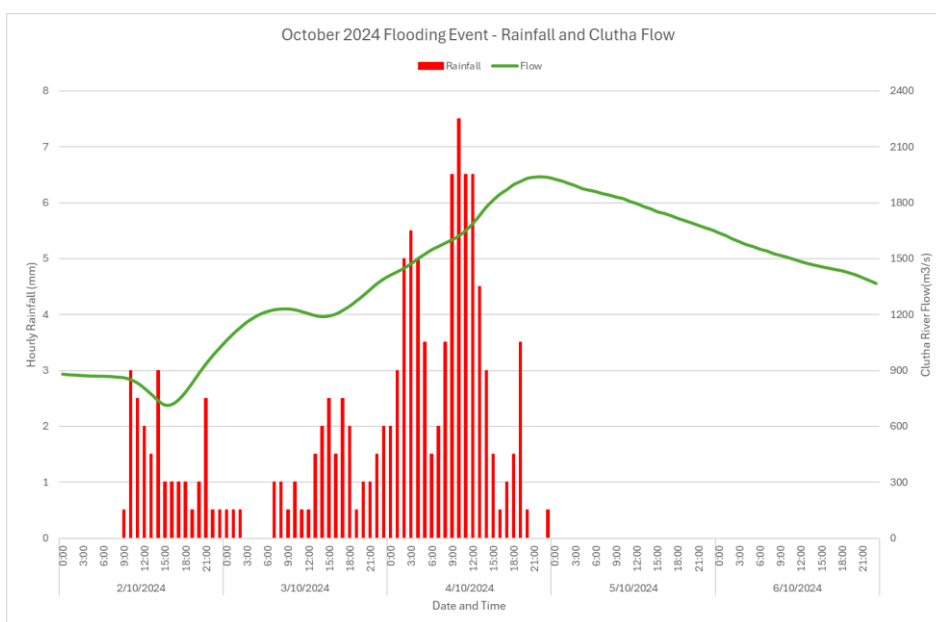
Figure 3.1: October 2024 Graph of Rainfall versus Clutha River Levels

Figure 3.1 below, displays the flows in the Clutha River in comparison to the Balclutha rainfall data.

River gauging information at the Balclutha site indicates that the Clutha River was rising steadily throughout the rainfall event and peaked around 1940m<sup>3</sup>/sec at 10pm on Friday, 4<sup>th</sup> October, at a similar time to the rain stopping. When rainfall at Balclutha was at its most intense, the Clutha River was flowing at around 1,600 to 1,700m<sup>3</sup>/sec.

Drainage from the Hospital Creek gravity discharge would start to be affected at a flow of approximately 1,200m<sup>3</sup>/sec. This would have occurred in the early hours of 3<sup>rd</sup> October before the higher intensity rain occurred.

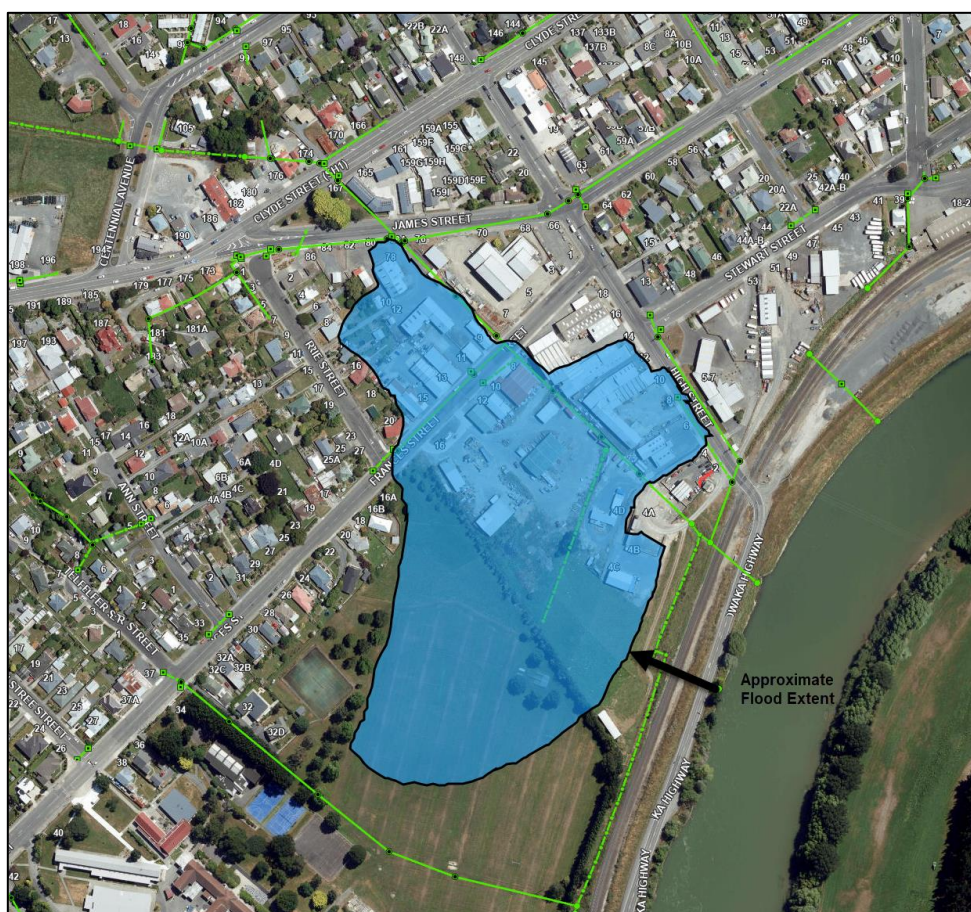
Figure 3.2: Approximate Flood Extent October 2024 - Flood Level around 5.9m NZVD2016

The extent of flooding is indicated in Figure 3.2. It should be noted that this includes flooding to several businesses as well as some residential properties on Ryrie Street.

A survey of the flood event indicates that flood levels in the industrial area were at an elevation of approximately RL 5.9m. This is similar to the surveyed peak flood level in the Clutha River.

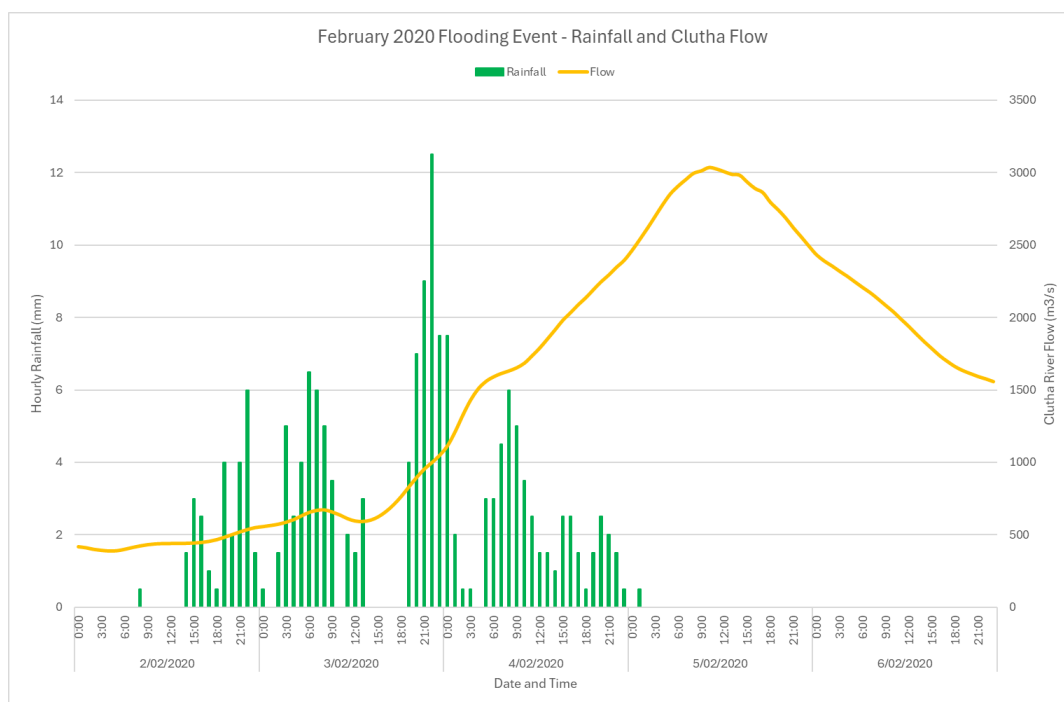
Figure 3.3: February 2020 Graph of Rainfall versus Clutha River Levels

In February 2020, there was another rainfall event with more rainfall than the October 2024 event that **did not** cause the same flooding of the industrial area. The February 2020 rainfall event was of a similar duration but there was more rainfall and it was of higher intensity than in October 2024, and had a higher calculated peak flow.

The level in the Clutha River peaked at a much higher flow (3,040m<sup>3</sup>/sec) but this occurred after the rain had stopped. Also, when the peak intensity rainfall was occurring, the levels in the Clutha River were low enough to not be impeding the gravity drainage outfall<sup>11</sup> (see Figure 3.3 for flow and rainfall).

In summary, the February 2020 event did not result in flooding as the river levels would not have impeded drainage to such an extent.
