# **STANDING COMMITTEES**

# INFRASTRUCTURE STRATEGY & OPERATIONS COMMITTEE

<b>Report</b>	Operations Update – Transportation
<b>Meeting Date</b>	21 November 2024
<b>Item Number</b>	1
<b>Prepared By</b>	James Allison – Transportation Operations Manager
<b>File Reference</b>	913122

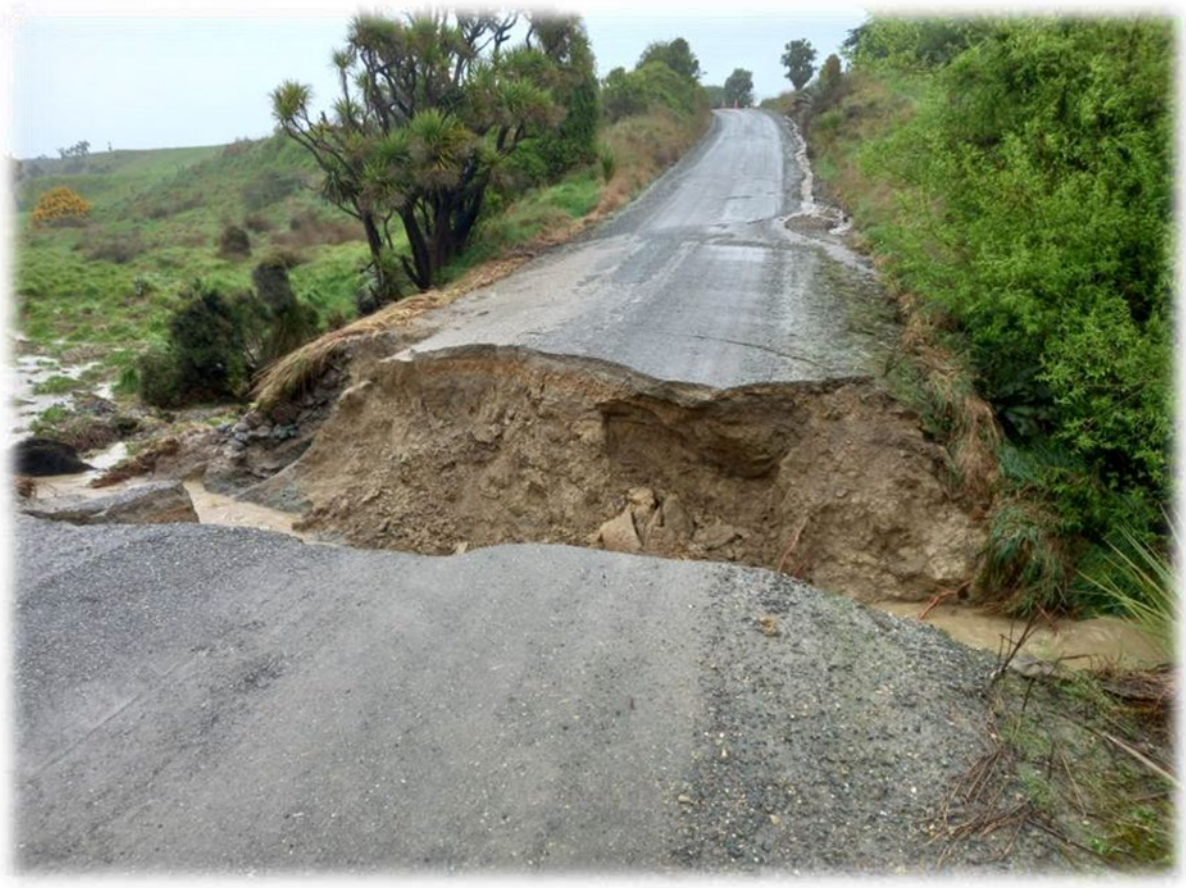
*Summer Hill Road Washout*

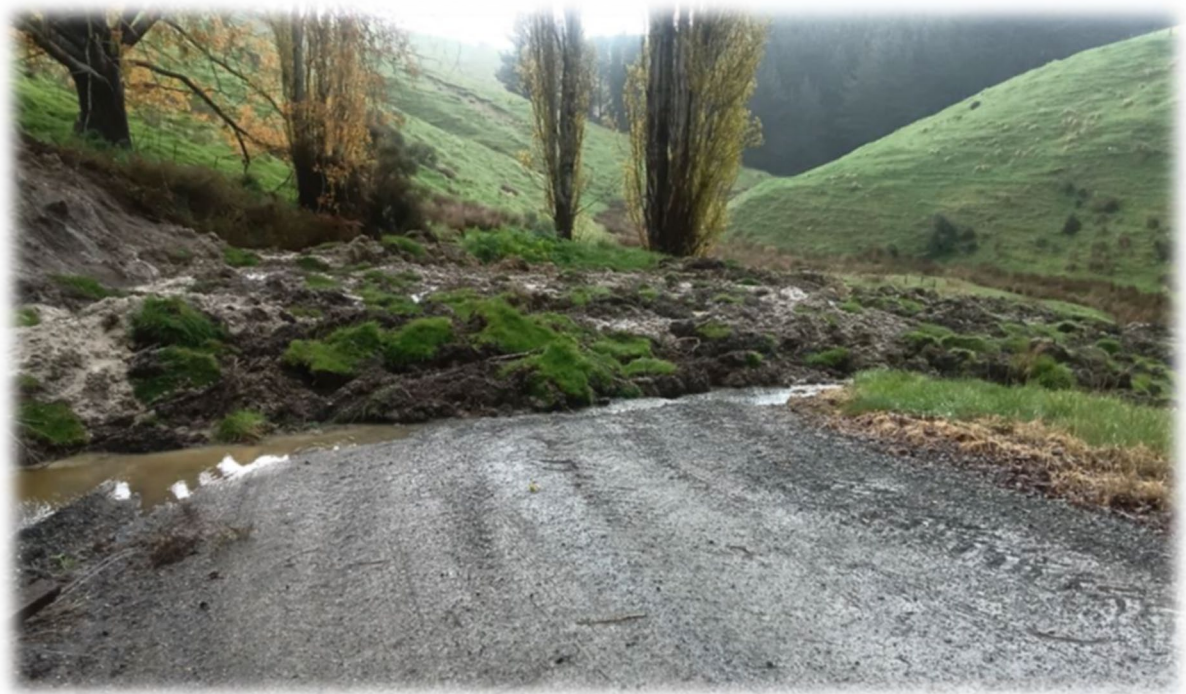
*Wingfield Road Slip*

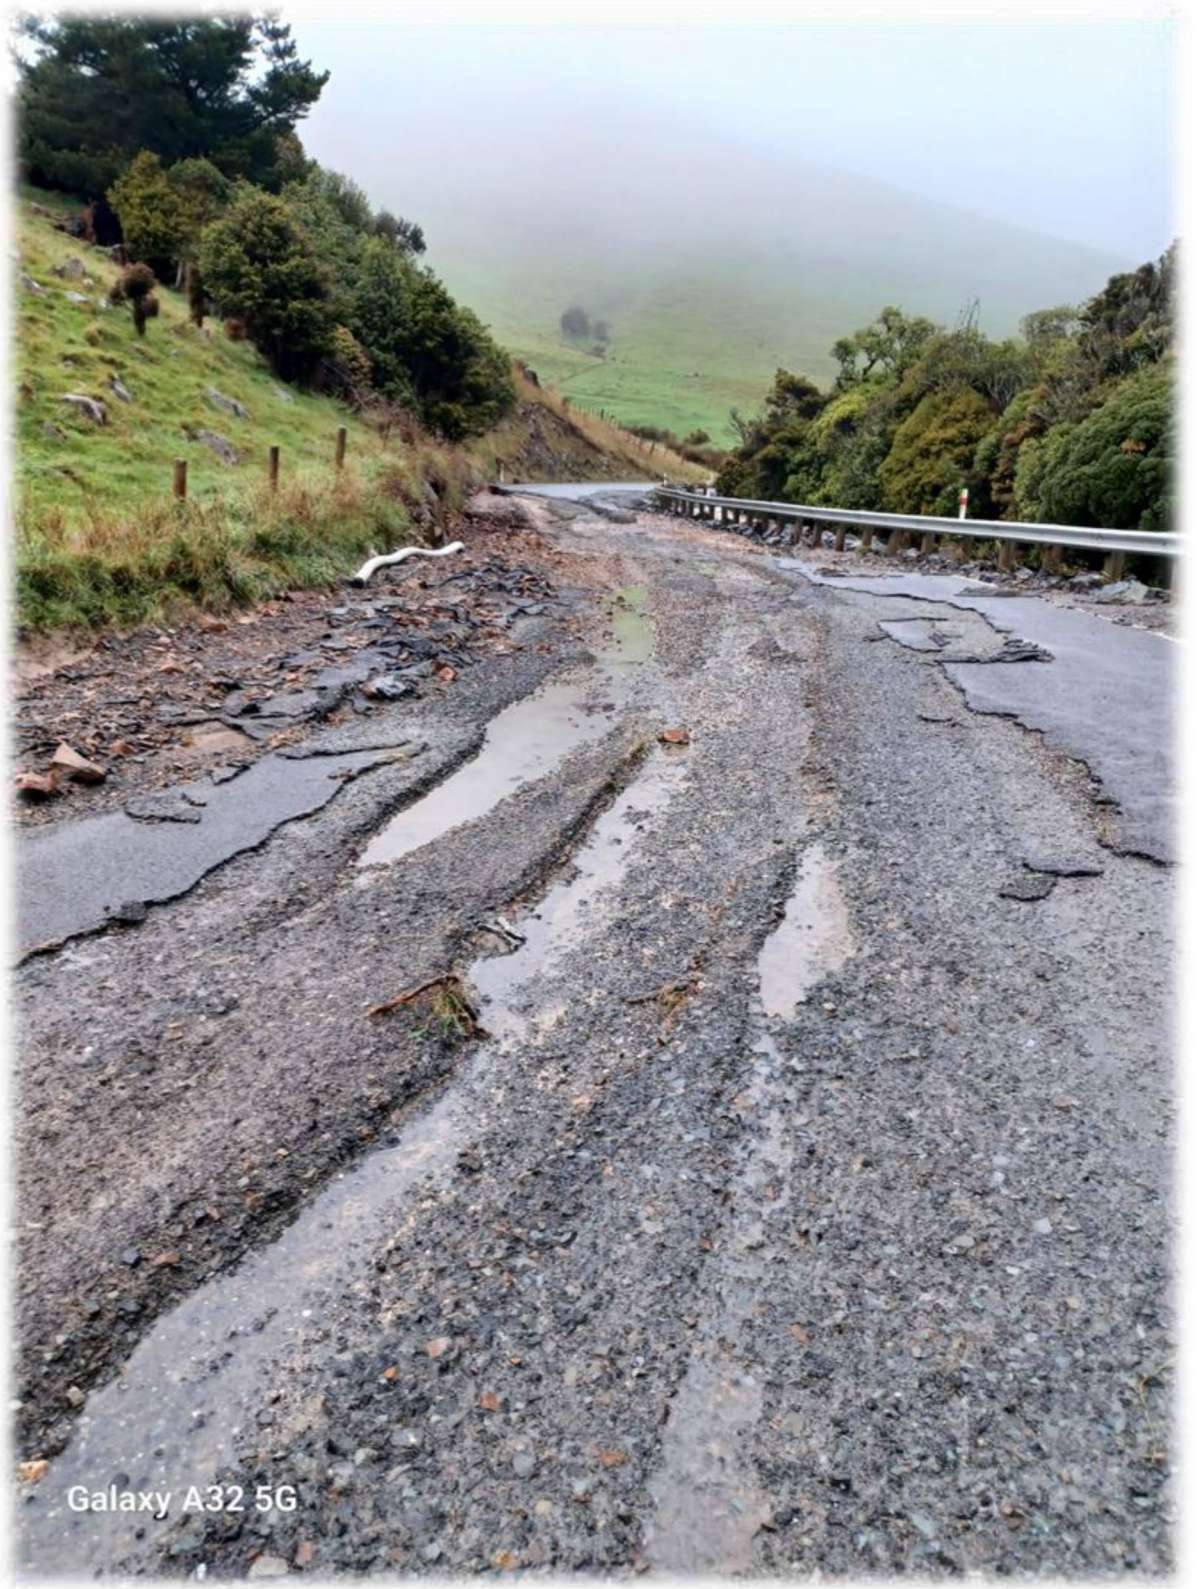
*Karoro Creek Road*

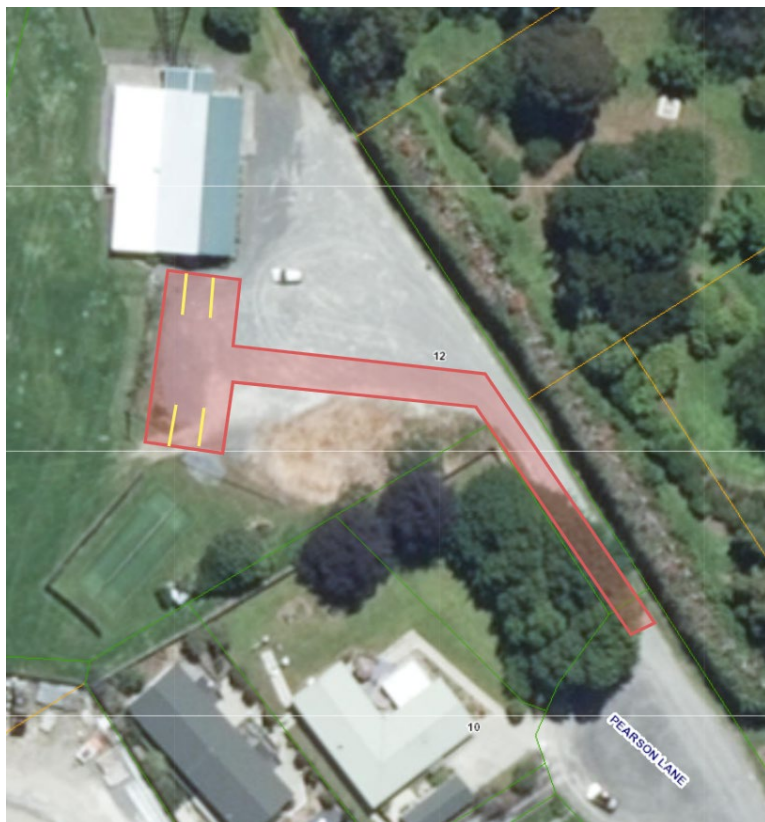
Figure 1 – Roadway and approx. car park area utilising capital budget – 6 parks

**Pearson Lane / Centennial Park Carpark:** A budget of \$24K was approved for sealing the car park in this area. Initial work has been completed and for this budget amount (including repairs to the incoming road and pothole filling) only a car park area for six cars can be constructed (see Figure 1 overleaf). However, an allocation of \$16K for maintenance work will be applied to this project from the Balclutha Parks Non-Routine Budget and this will enable an area for approx. 22 car parks to be installed. The wider area that will not be sealed will hopefully be able to be improved over the next year by using asphalt millings to provide a better surface – similar to the work undertaken at the at the Riverside Reserve Road and parking area.

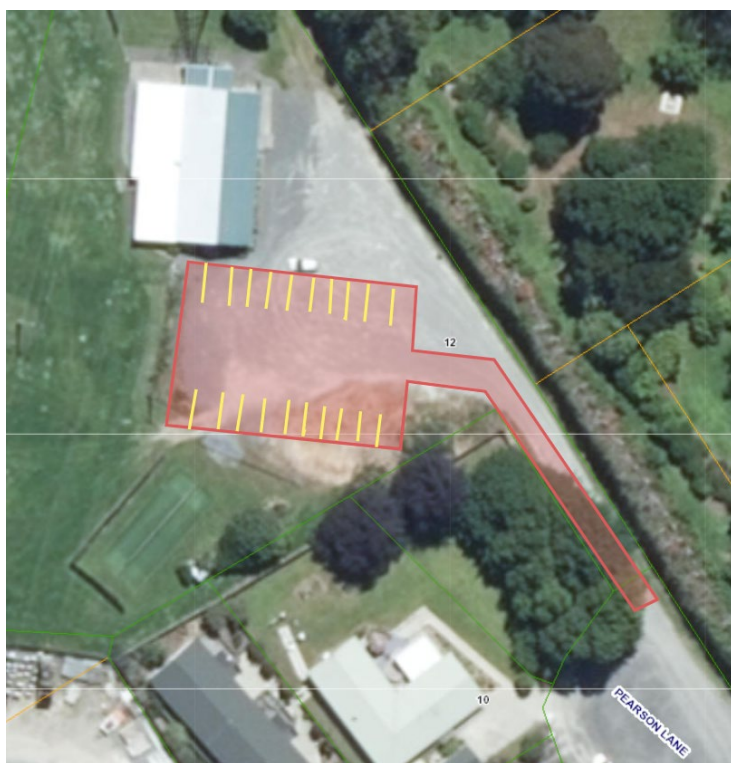
Figure 2 – Roadway and approx. car park area utilising capital budget + some non-routine budget - 22 parks

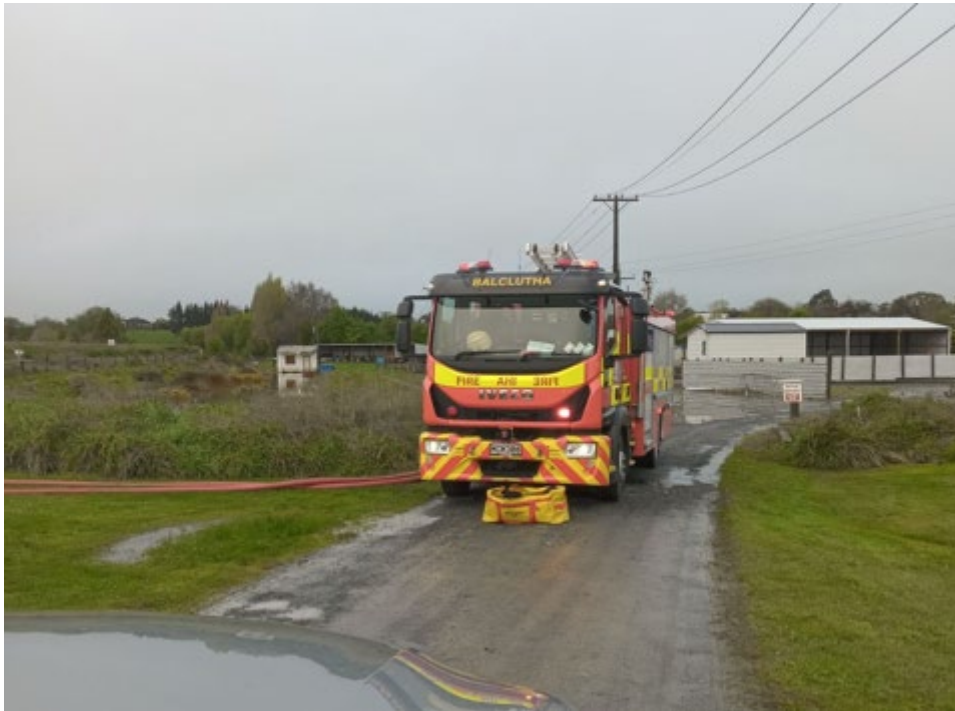
*Balclutha Fire Brigade assisted with pumps at Hospital Creek*

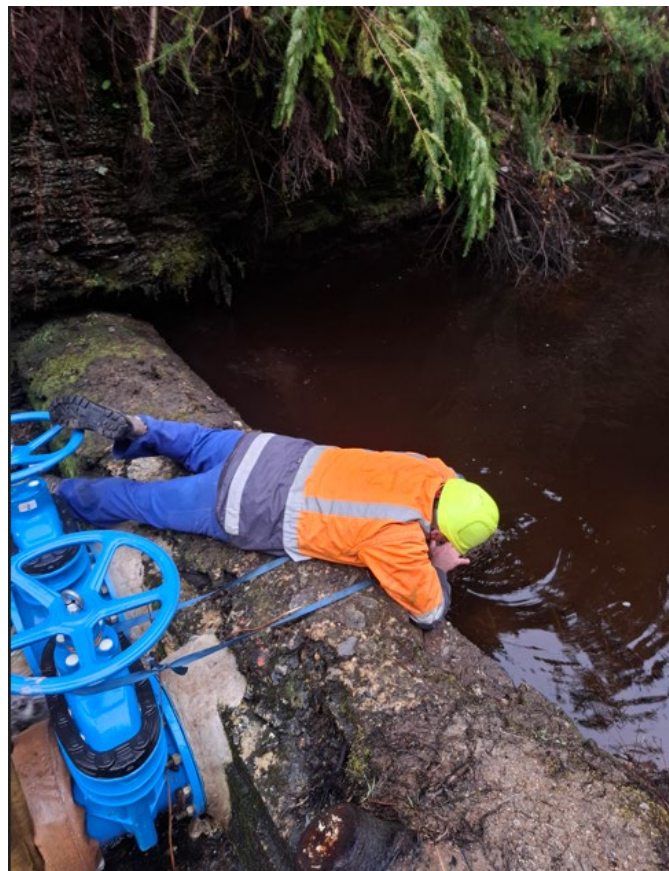
The siphon valves that were installed are around a third open and it is expected that to provide surety of supply through summer that they will be fully exercised. The siphon is pictured in the images below, together with some sections of the open race. The bottom image shows an area of slight land slippage, which will be piped.

*Close up inspection with the siphon valves on the left of the photo*

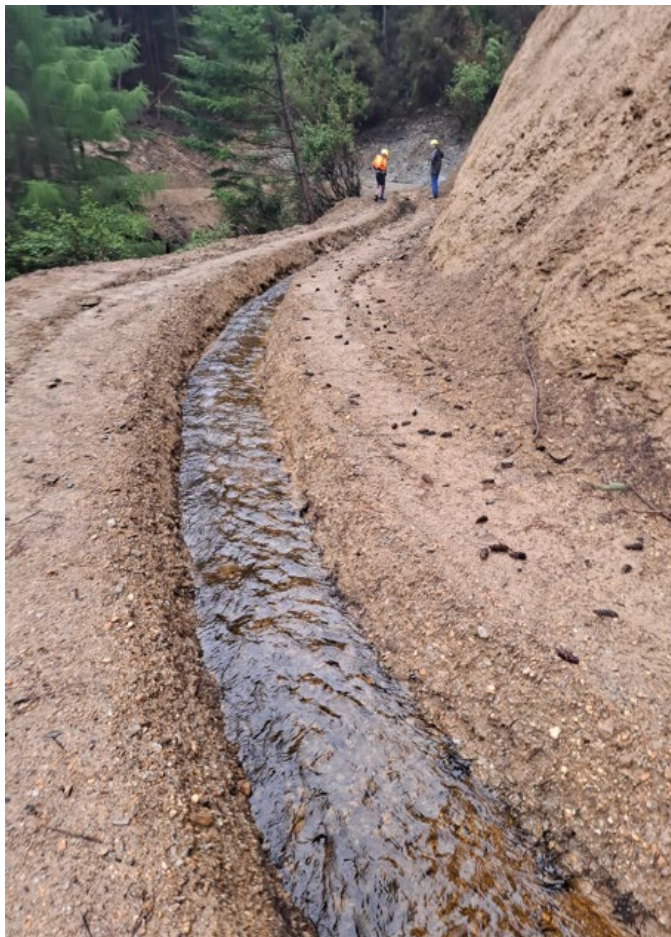
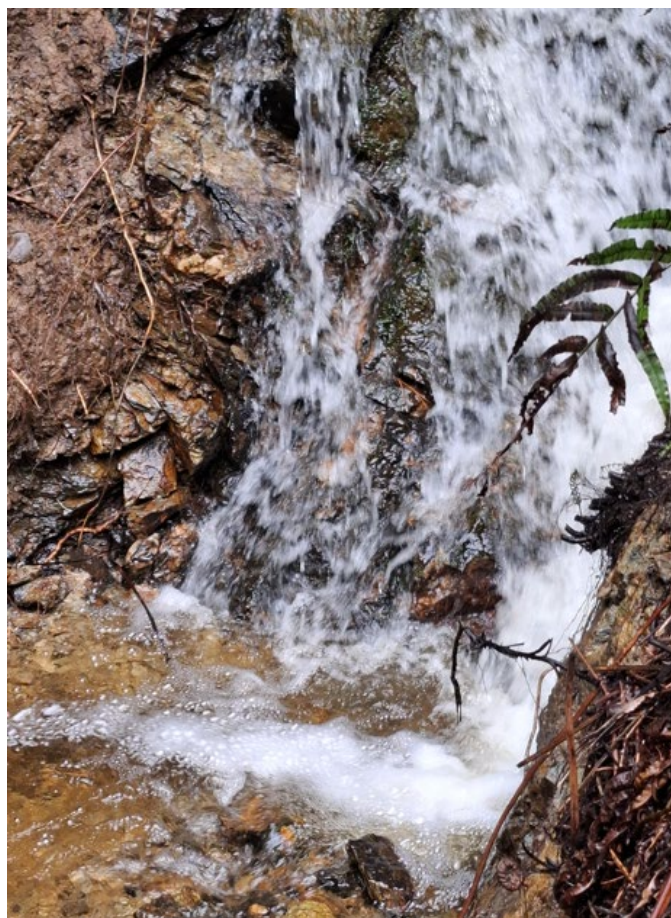
*Clear water off the race*

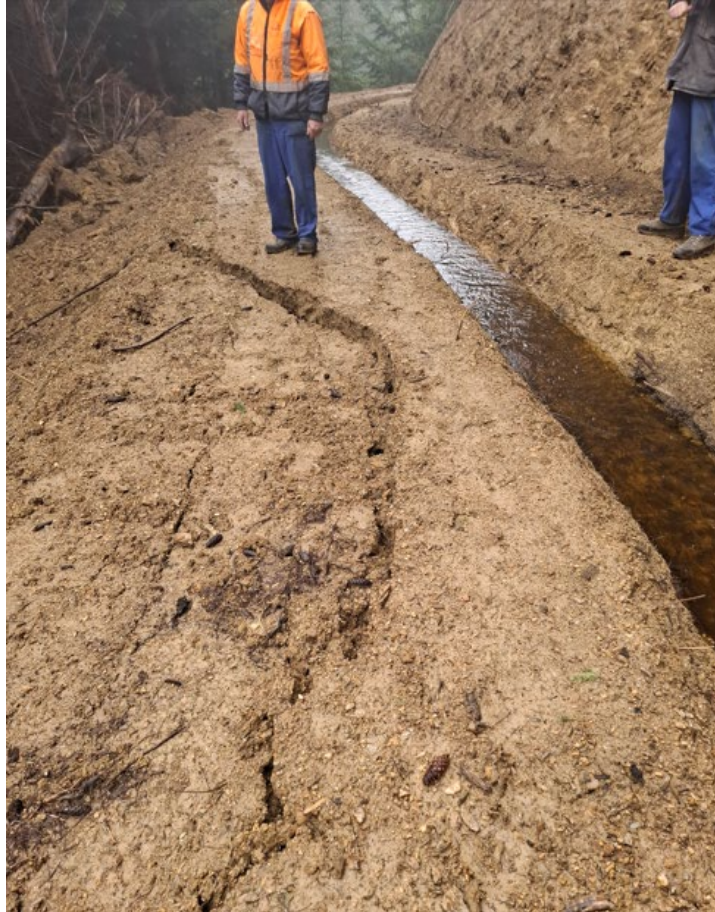
*Small slippage on the left of the race*

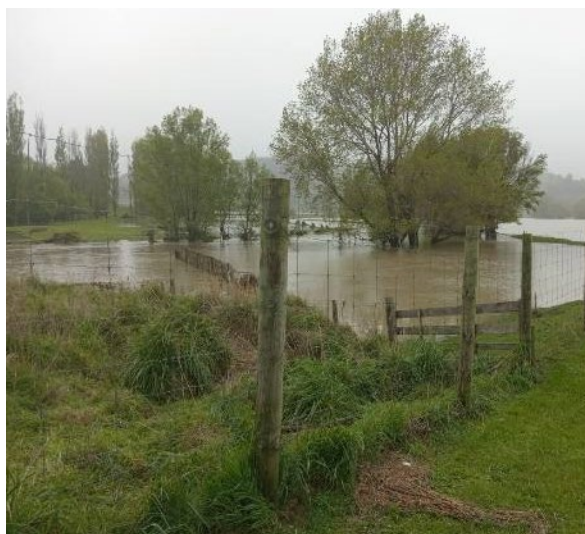
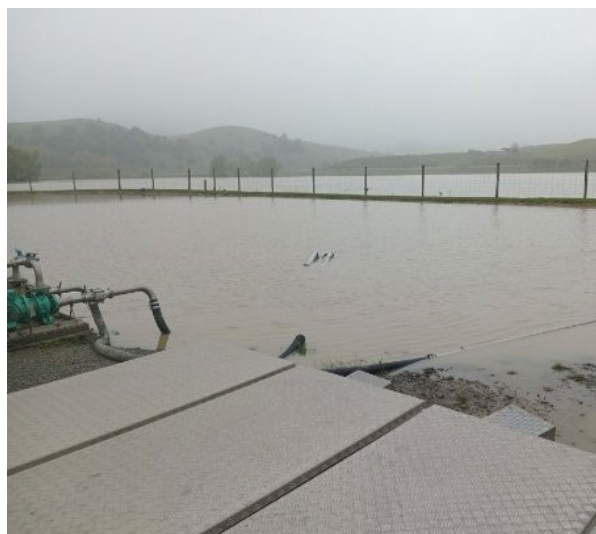
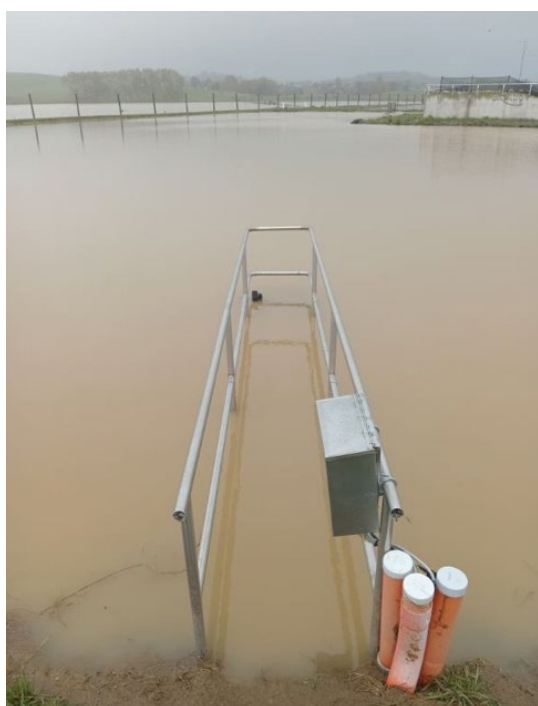
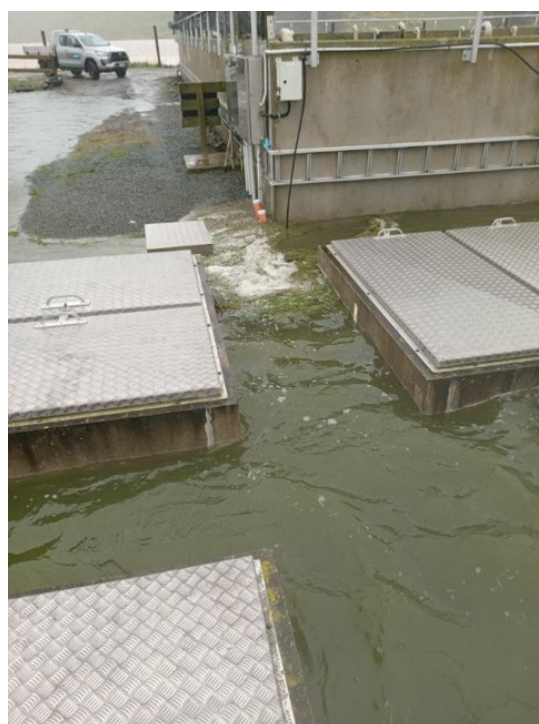
*Owaka Wastewater Treatment Plant under water*

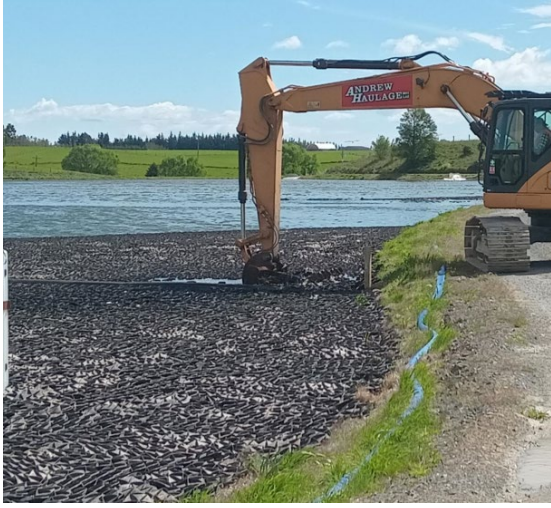
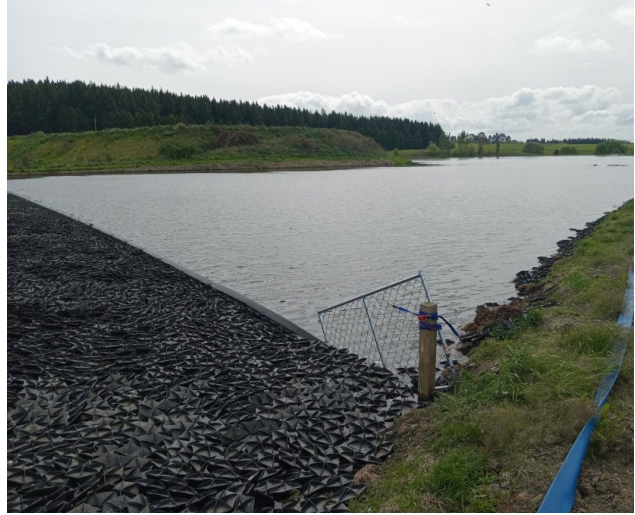
*Balclutha Wastewater oxidation pond - hex covers being moved to the correct side of the curtain & in place.*

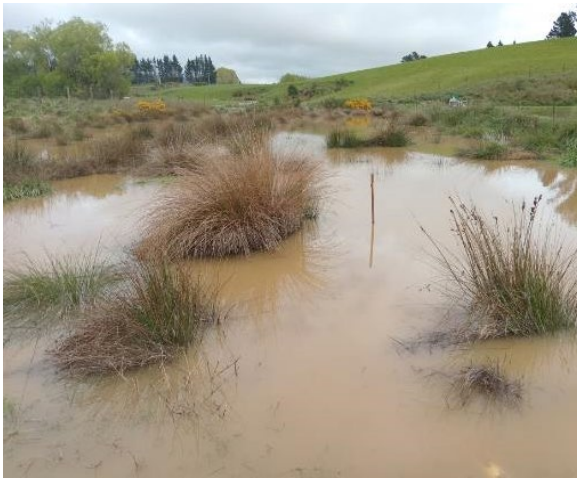
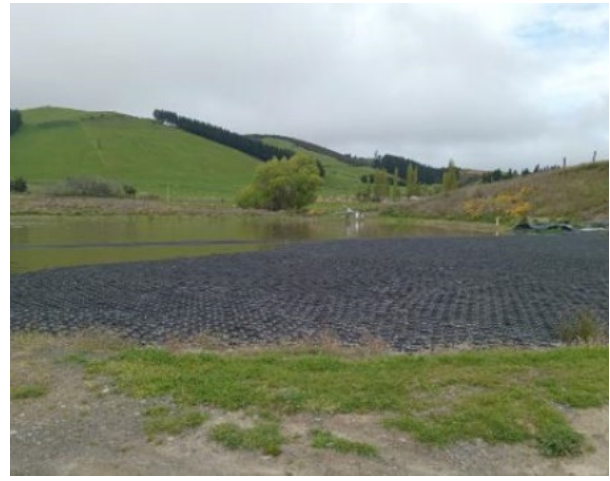
*Waiholo Wastewater Treatment Plant – inundated wetlands & still displaced hex covers.*

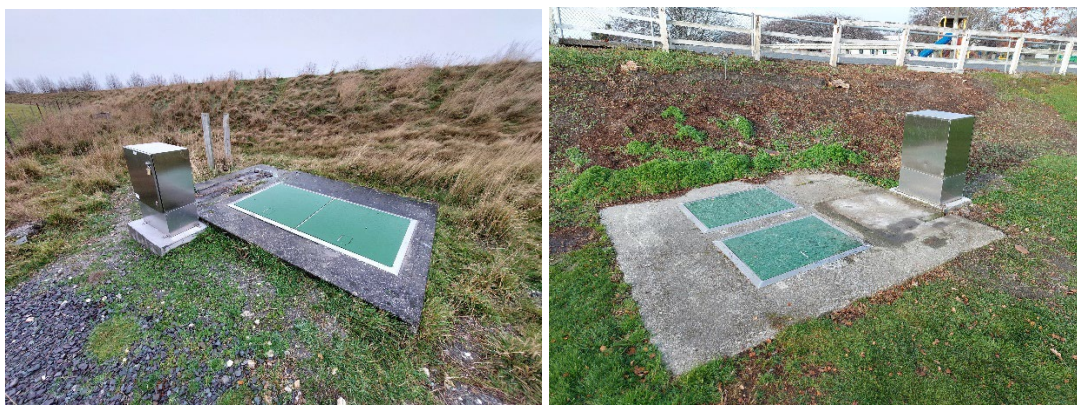
*Stormwater Small Switchboard*

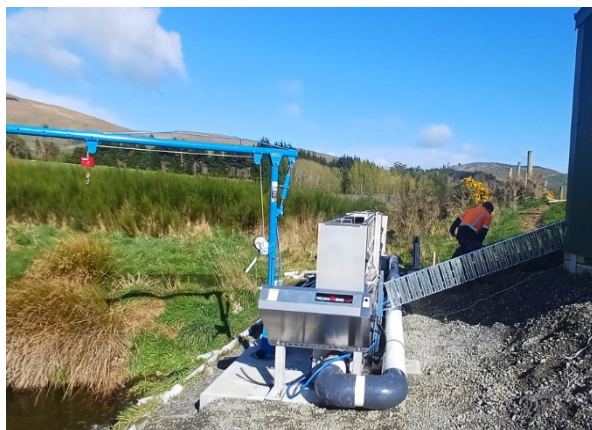
- Heriot/Kaitangata Waste Water Treatment Plant: The project is complete and under the defect's liability period. There is no definite end date for the Final Completion at this stage as all the defects are required to be remediated. The operation team is investigating the defects and working with the contractor for remediation.
- Clinton Waste Water Treatment Plant: This plant is also fully commissioned and in operation. We are finalising the defects list and working with the CDC Operation Team for the contractor to remediate before the issue of the Practical Completion Certificate. The defects are aimed to be remediated by the end of this year. However, the contractor is focusing on getting Balclutha WWTP commissioned first before remediating the minor defects at Clinton.

*UV at Clinton Waste Water Treatment Plant.*

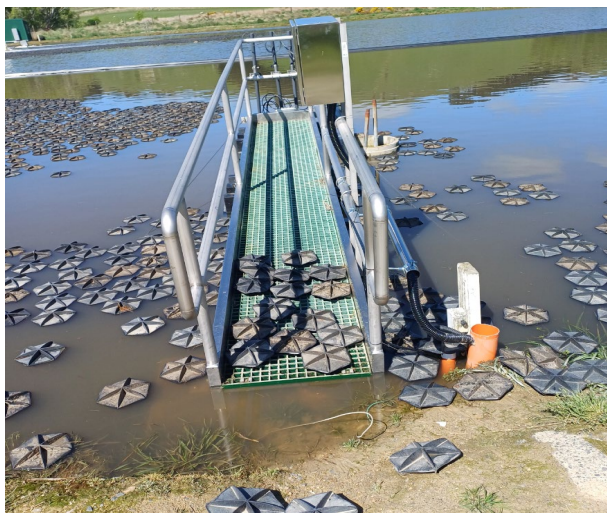
- Waihola Waste Water Treatment Plant: The final stage is working on the screening backwater supply. However, the work is delayed due to the water level in the wetlands (due to the recent flood event). See below (hex covers are floating on the gantry due to the rising level of the pond). The plant is 95% commissioned and we are finalising a defects list for the contractor to remediate before the issue of the Practical Completion Certificate. The work will be resumed until the wetland water level is low. The defects are aimed to be remediated by the end of this year. However, the contractor is focusing on getting Balclutha WWTP commissioned first before remediating the minor defects at Waihola.

*Hexcover on the gantry at Waihola WWTP*

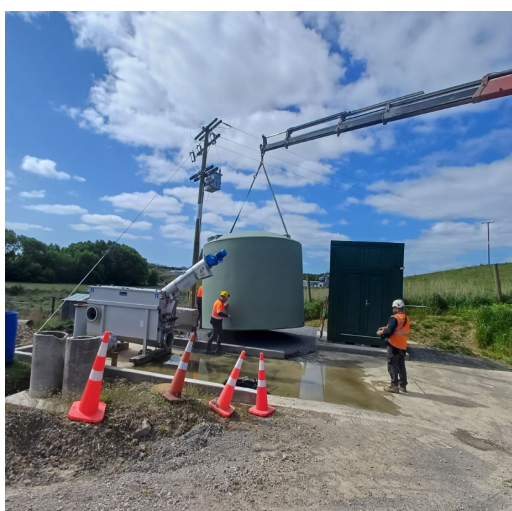
- Balclutha Waste Water Treatment Plant:**  
 The inlet screen tank and the waterline are installed, and ready to be connected to the screen for its backwash system (see below). The next stage is to continue the electrical work and recirculation pumps and finish off the screen work. It is aimed to be fully commissioned before end of this year.

*Inlet screen tank setting for Balclutha WWTP Inlet*

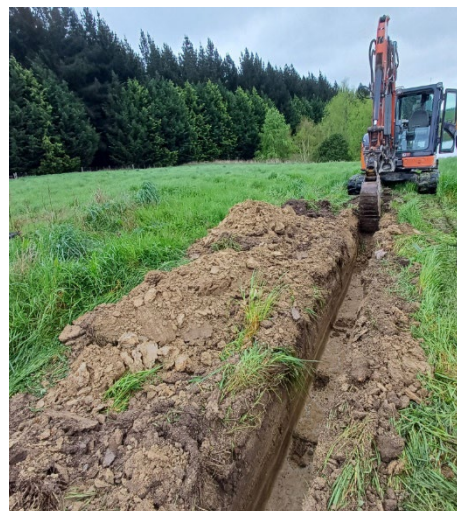
*Screen waterline to setting Balclutha WWTP inlet*

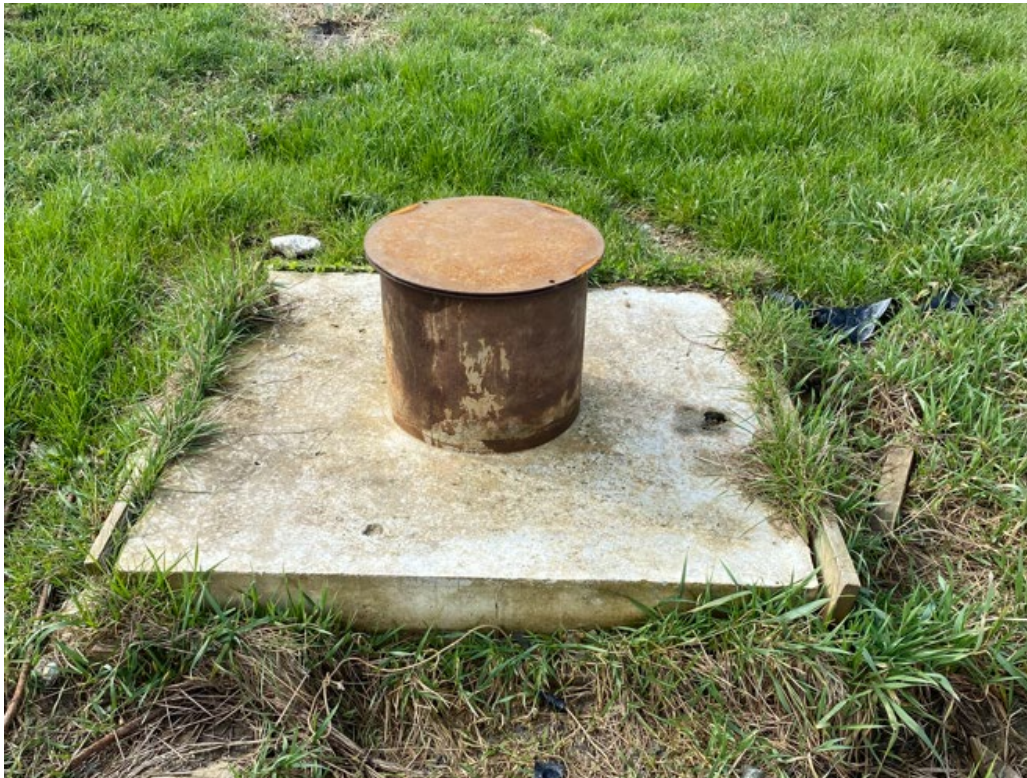
**Photo 1 – Well 1**

- Pipework and ducting are currently being installed between bores. Completion is expected by the end of October 2024.
- Pricing received for the borehead and electrical installation. All pricing is now received for the Borefield.
- The new borefield will include an extension to the Pomahaka-Clydevale treatment building where the new switchboard will be installed.
- The pumping testing indicated the three Greenfield bores reached the overall scheme target flow of 120 L/s, with each bore reaching 70 L/s during testing, however, 50 L/s peak operational flow for each bore is recommended.
- Water quality results from Well 1 show it is suitable to supply water to the scheme. Water quality results for Wells 2 and 3 were not taken at the correct time (during flow testing) and need to be re-tested by the drilling contractor. Re-test is expected to happen in the month of October.

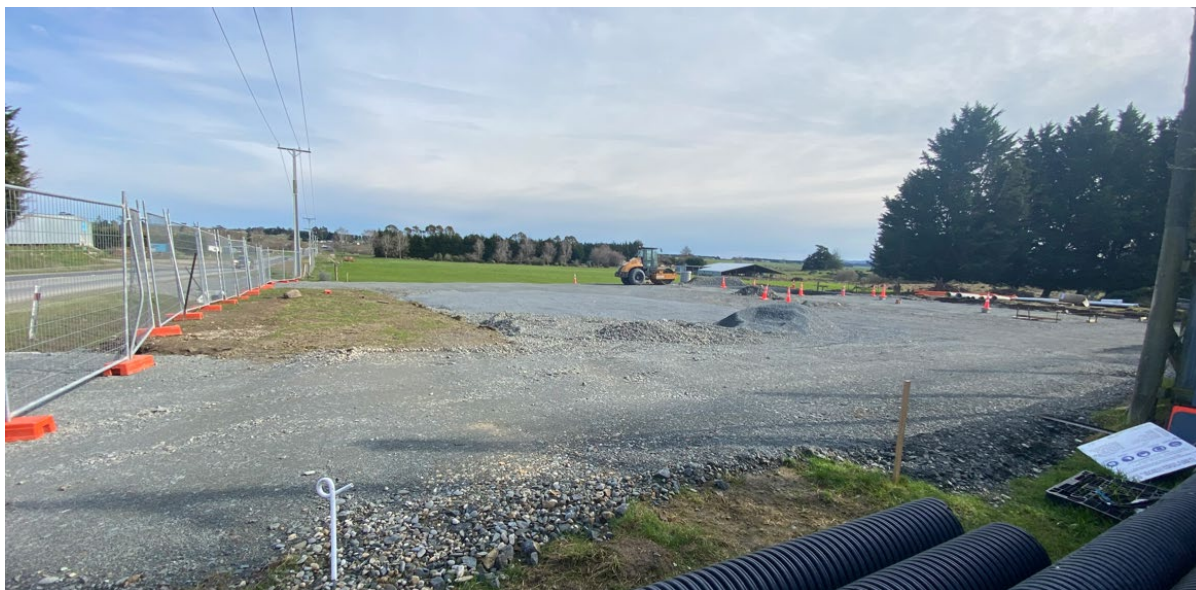
- Civil works underway
- Building design underway
- UV units ordered
- Transformer ordered
- Reservoir design received and amendments proposed
- All pricing received

**Photo 2** – Work underway on the WTP site

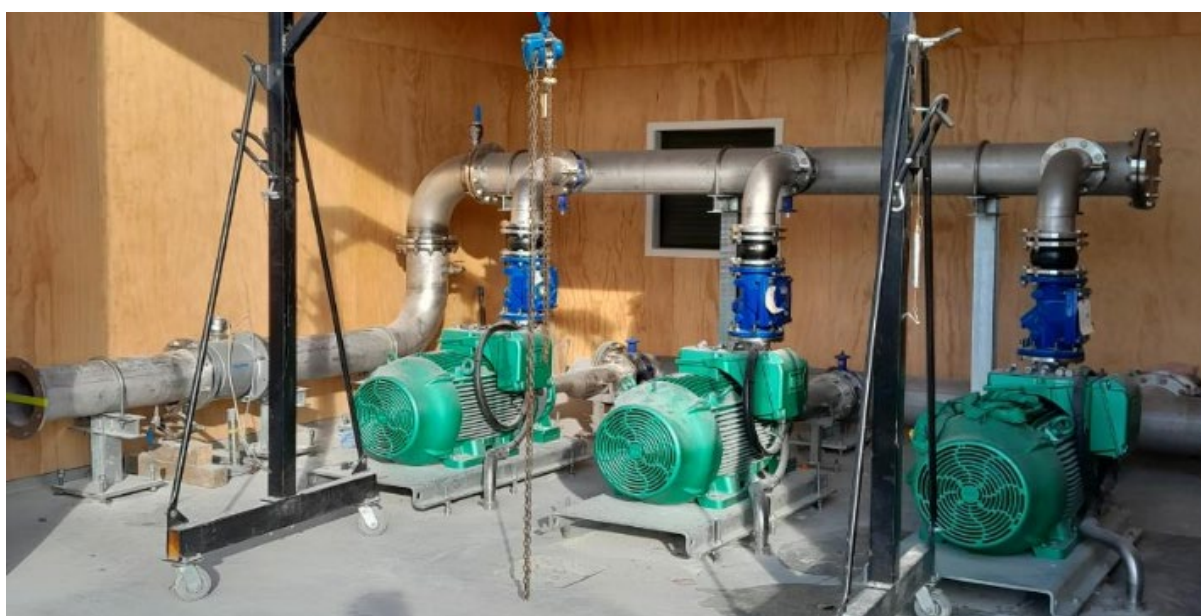
- Complete by the end of September
- Tank installed
- Building constructed
- Switchboard in place
- Transformer installed
- All underground pipes installed
- Aboveground pipework in progress (90% complete)
- A connection to the transformer from the power poles (including easement) is required before powering up the pump station.

**Photo 3** – Lower Greenfield Pump Station – pumps and pipework installed.

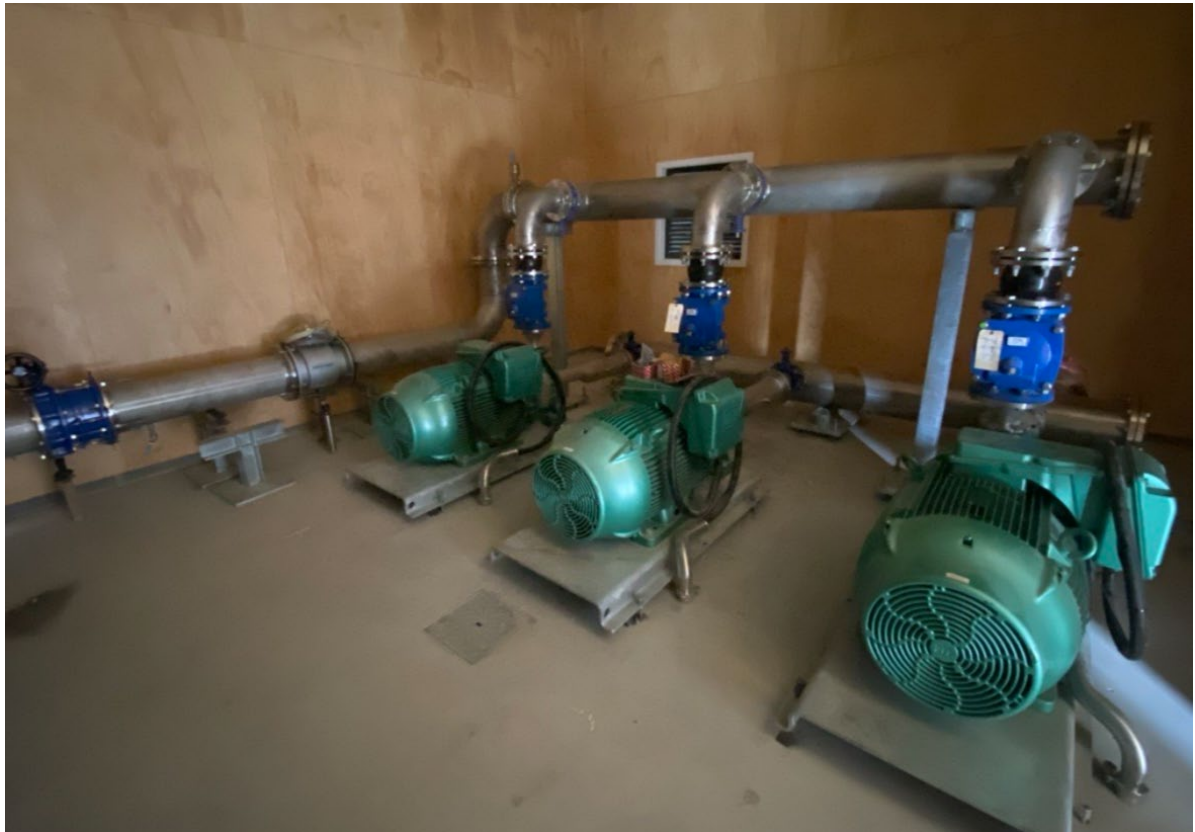
- Complete by the end of September
- Tank installed
- Building constructed
- Switchboard in place
- Transformer installed
- All underground pipes installed
- Aboveground pipework in progress (95% complete)

**Photo 4** – Upper Greenfield Pump Station – progress on the pipework

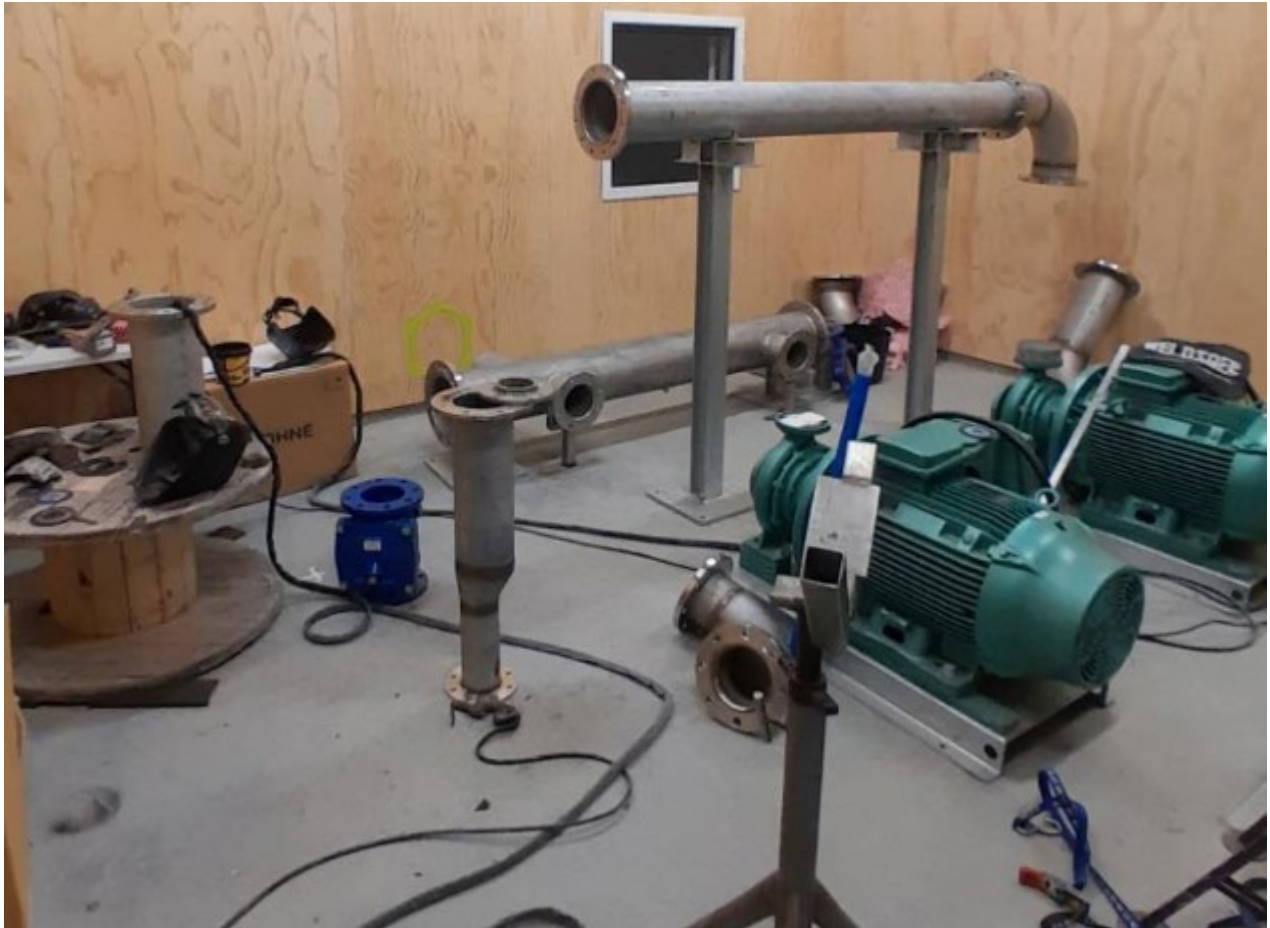
- Building constructed
- Switchboard installed
- Aboveground pipe in progress (80% complete)
- Transformer still to be installed

**Photo 5** – Cairn Road Pump Station – Progress on Pipework

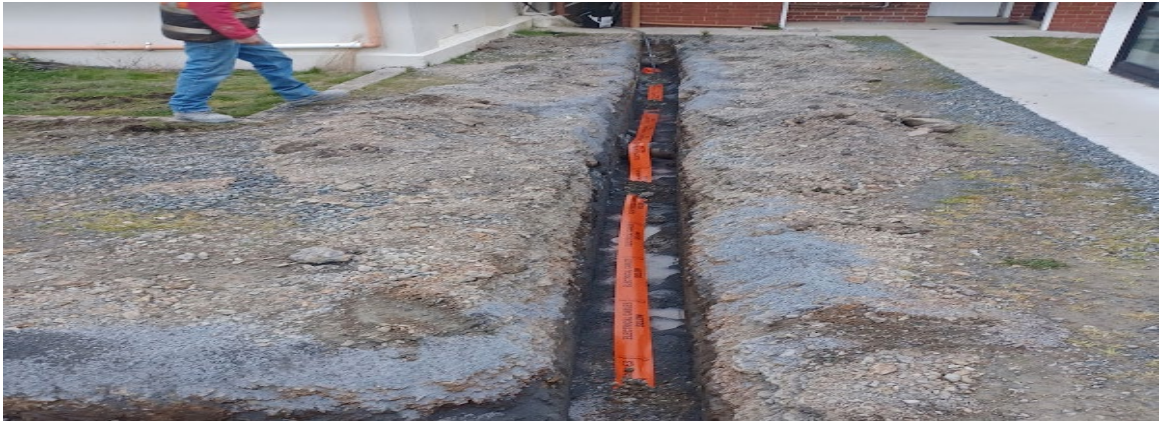
- In October, stage 3 of the underground power cable installation along the East Side of Union Street. Concurrently, the Ø63 rider main was installed within the same trench, with all required separations maintained between the utilities. The progress was notable, with the project advancing and is ahead of schedule.

*Inside property connection with power cable installed under crusher dust and warning tape on Union Street.*

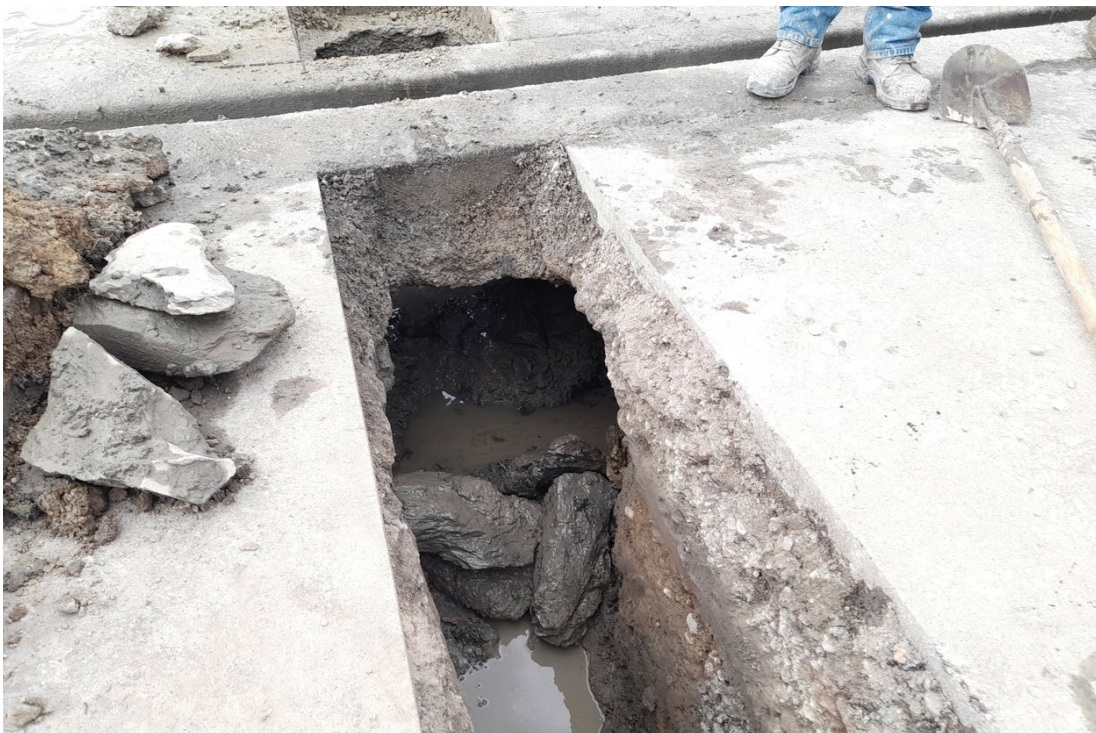
- On the last section of duct installation across Abercrombie Street, an unexpected blue stone culvert was uncovered. As the trenching was deeper than the existing culvert, water began to fill the trench. Work was immediately halted, and both the Heritage Properties team, Engineers Rep and CDC representatives were called to assess the situation.

*Abercrombie St. - Blue stone Culvert Pre 1900 Feature*

- After discussion and recommendation from the Heritage Properties we submitted a new design comprising of the remedial action to the stone culvert without further disturbance. After consultation with the relevant authority an agreement on the appropriate course of action was reached and work resumed. Majority of works on the initial contract is near closure with testing to be undertaken.

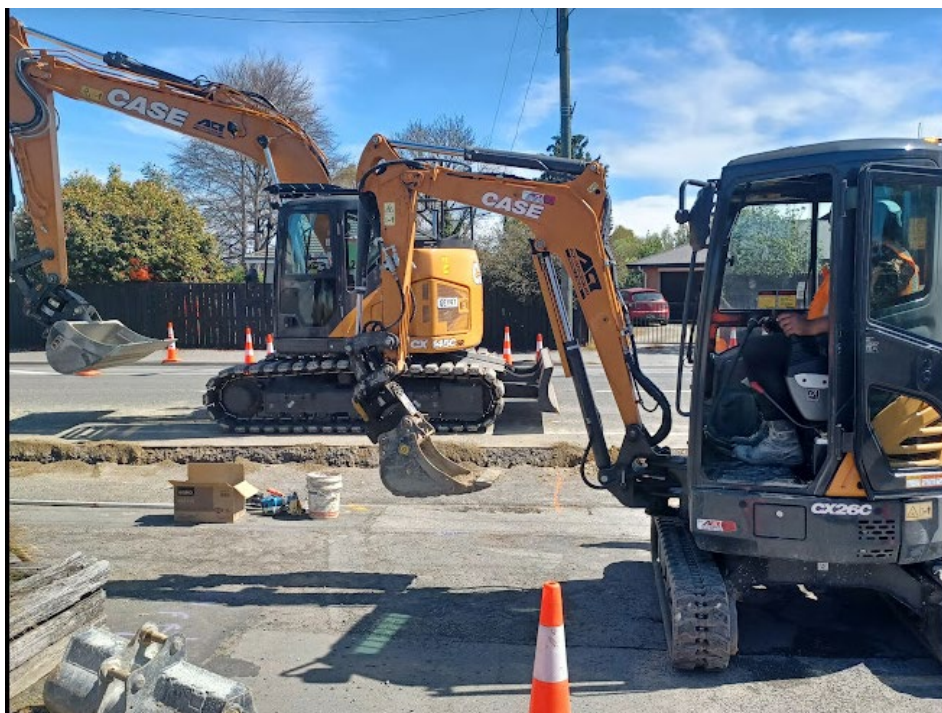
- Separable Portion A (Stormwater Pipeline Extension)** – The scope involved replacing the Ø225 earthenware pipe with a Ø300 UPVC pipeline, extending from the Abercrombie Street manhole to the Cowper Street manhole. A total of 128 meters of Ø300 UPVC stormwater pipe was successfully installed, along with 5 x stormwater lateral connections and a mud tank connection.

Milton Union Street – Machinery used on the Stormwater Pipeline Extension.

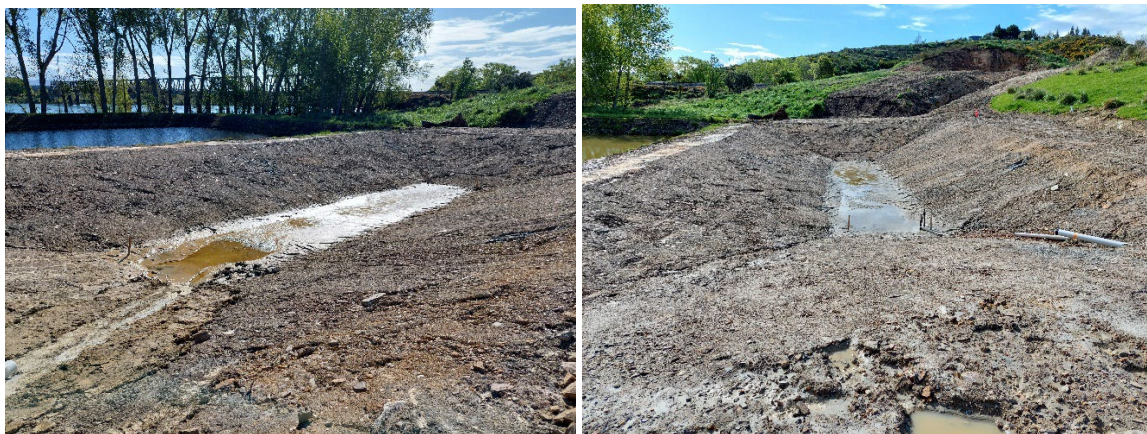
- Isaac's have finished shaping up the leachate pond.
- Isaac's will just tidy up the site, put topsoil and grass seeds and they will be finished with all the site work.

*New leachate Pond Levels*

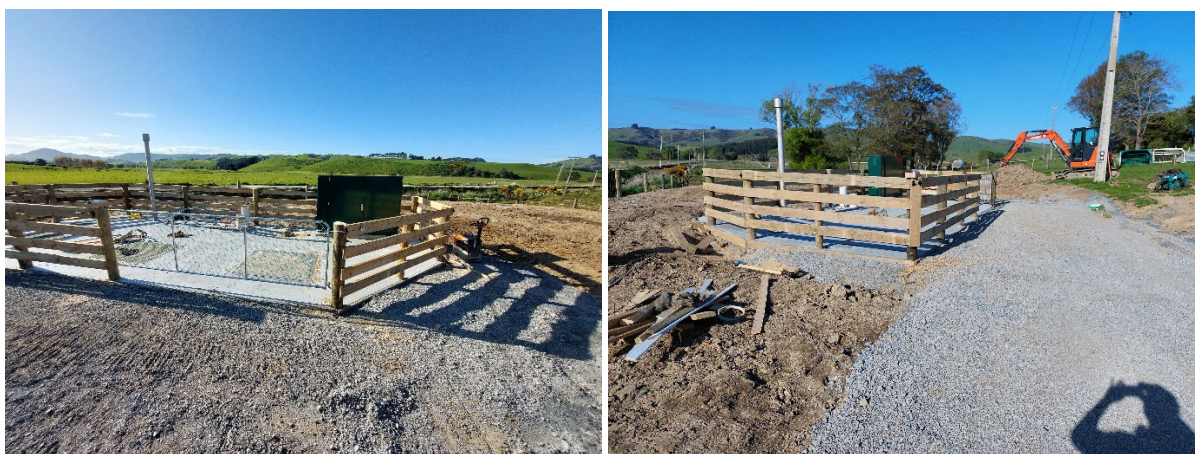
- Isaac's have finished the installation of the plinths and the new switchboard.
- Isaac's finished the installation of the concrete pad and fences.
- Isaac's will fix the fence and tidy up the site and they will be finished with all the site work.

*Owaka New Fence*

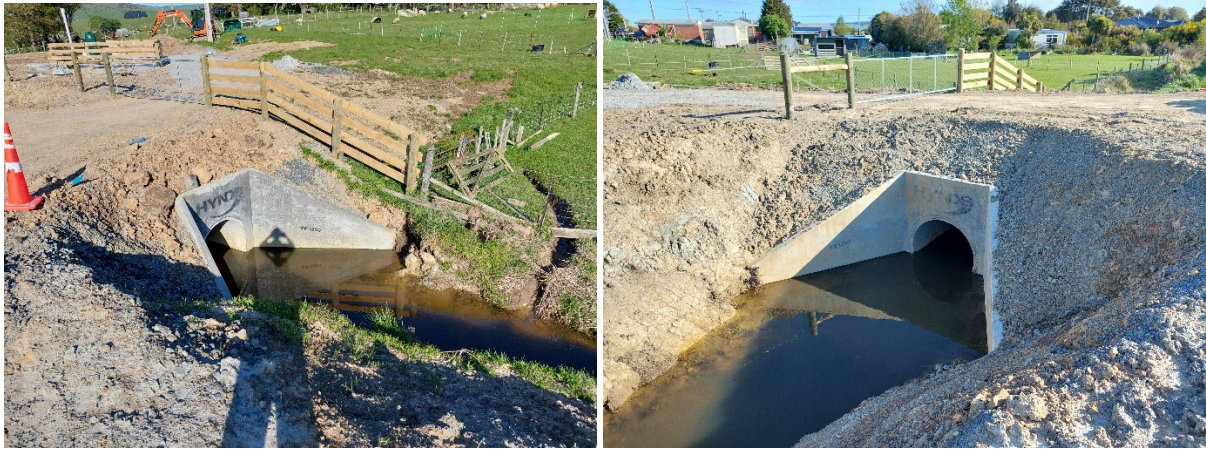
*Owaka Culvert*

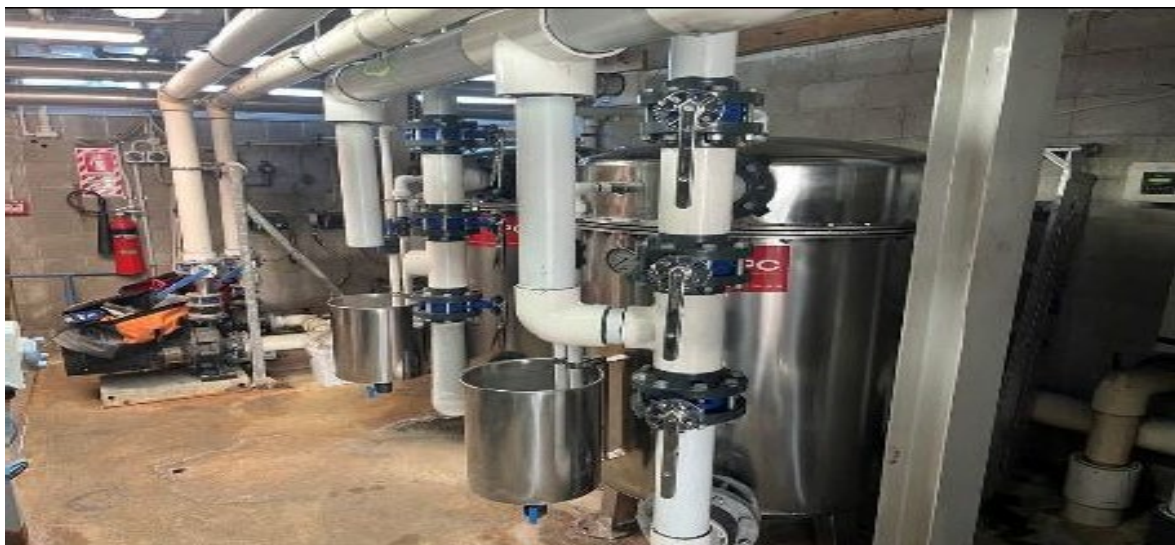
- Additional improvements of the filtration system, a vacuum transfer and sodium bisulphate mixing tank is on track for mid-December. The installation will not affect the day-to-day running of the public pool.

*Balclutha Centennial Swimming Pool Perlite Filters*
