# **STANDING COMMITTEES**

# INFRASTRUCTURE STRATEGY & OPERATIONS COMMITTEE

<b>Report</b>	Operations Update – Transportation
<b>Meeting Date</b>	21 November 2024
<b>Item Number</b>	1
<b>Prepared By</b>	James Allison – Transportation Operations Manager
<b>File Reference</b>	913122

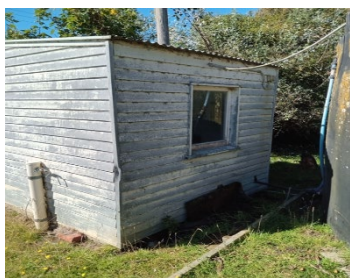
The site assessment was carried out from ground level and considered the overall condition of the building, and all assets contained inside, the deterioration of a pump station building and switchboard over time is a matter of concern. Additional quotations are in progress of been obtained to proceed awarding the work targeted for later November.

*Mt Mistake Pump Station Exterior*

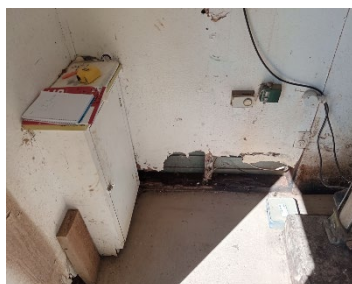
*Mt Mistake Pump Station Interior*

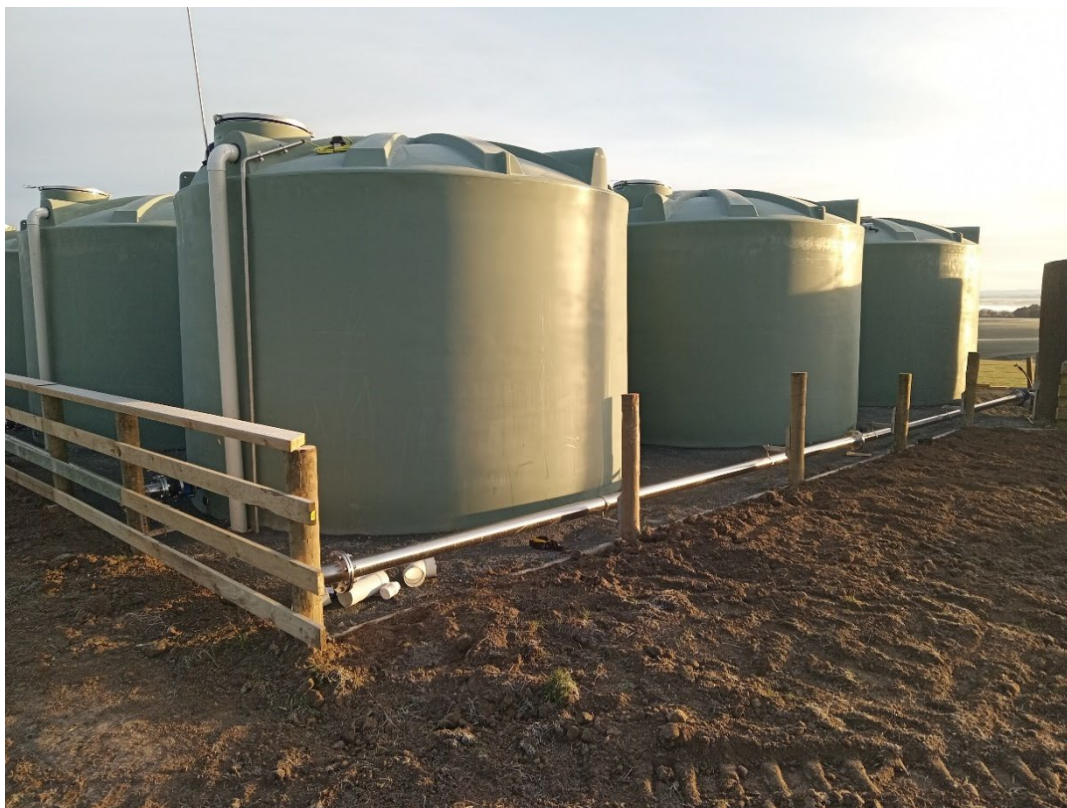
*30m3 New Plastic Tank Farm Reservoir*

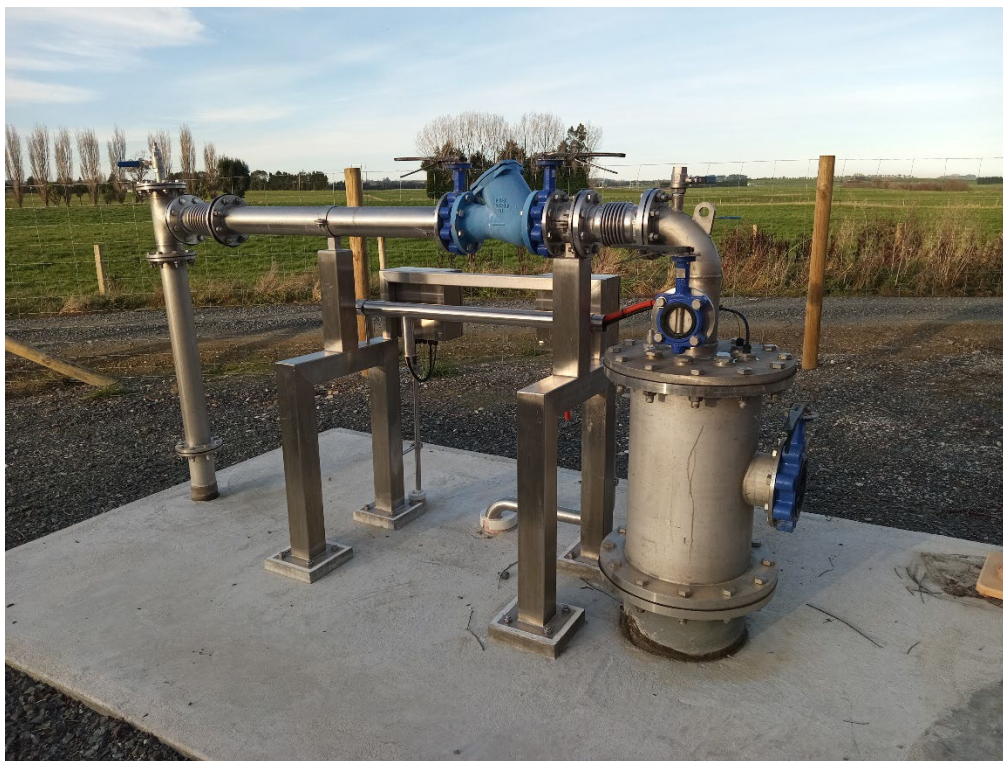
*Clydevale WTP Bore No.4*

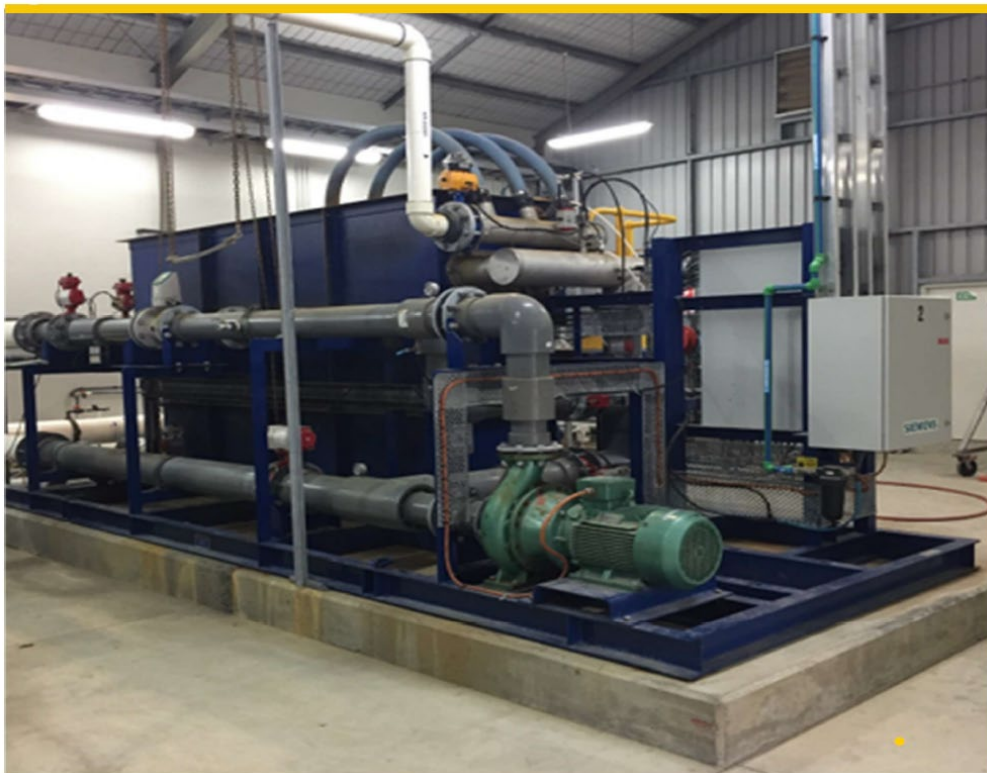
The proposed recommendations and associated costs to upgrade the Milton WTP capacity from 3 MLD to 5 MLD are approximately \$4.5 million. We are currently exploring alternative options to achieve this capacity increase.

*Milton WTP Membrane Unit No.1*

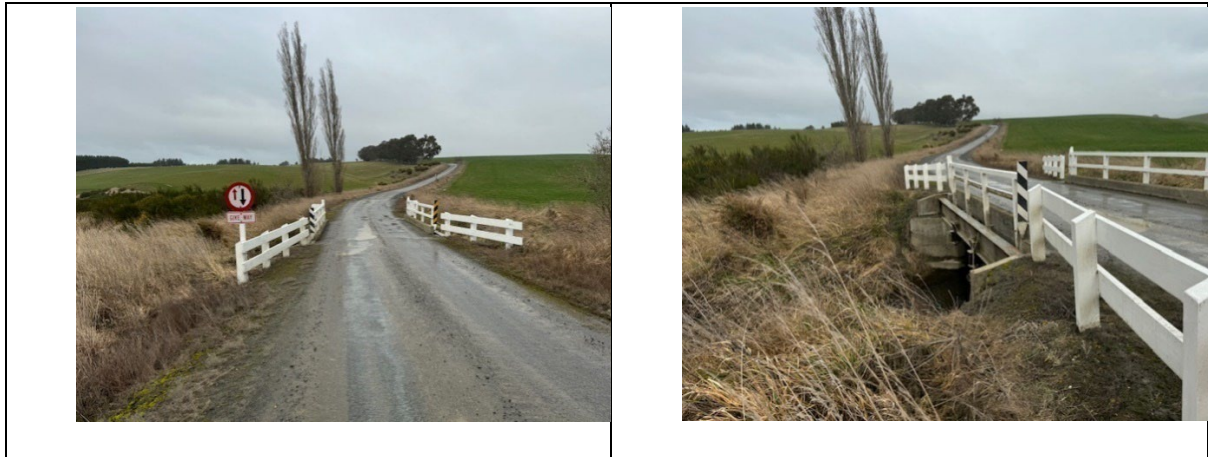
Bridge 121 – Taumata Road - Clinton

- Surveying and soil investigation physical works completed for package 1 and reports are underway, physical works ongoing for 2 bridges in package 2 (Bridges 173, 223).
- Design and Tender Documents for package 1 are underway and planned for completion in January 2025.
- The Tender of package 1 is planned to be published on GETS by February 2025.

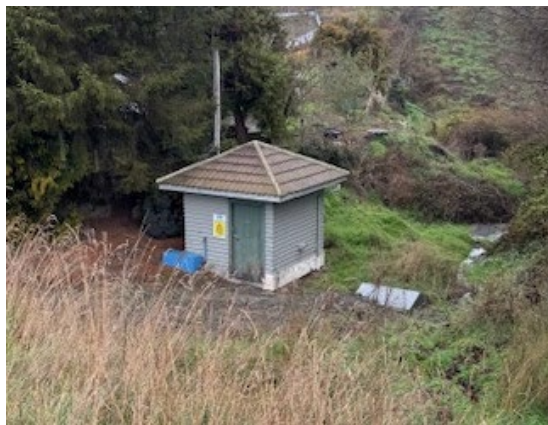
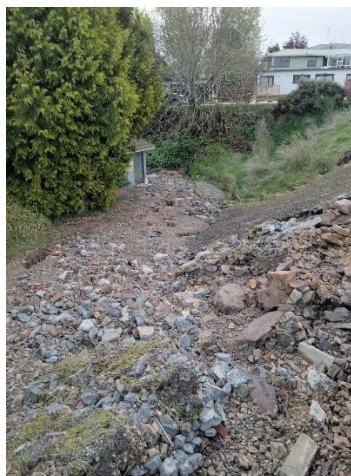
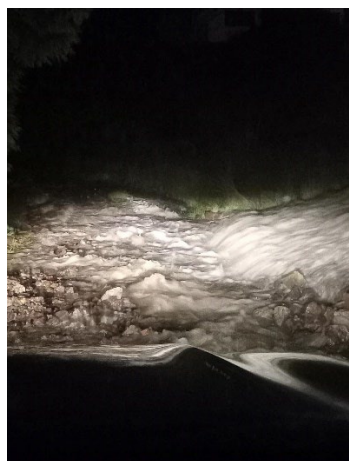
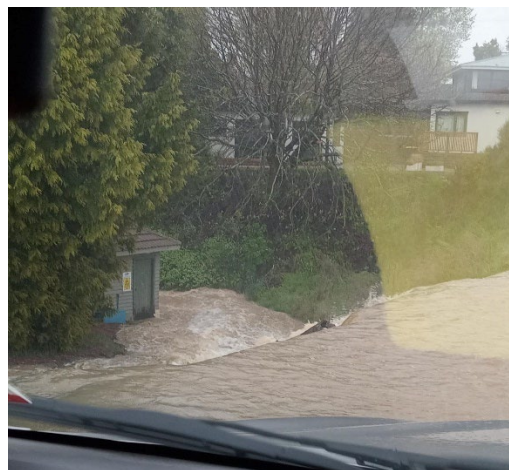
**Gormack St Pump Station**

- Assessment completed by consultant (GHD).
- Design and Tender Documents for Gormack PS are underway and planned for completion by end of November.
- The Tender of Gormack PS is planned to be published on GETS by November 2024.
- Depending on the tender outcome and the budget, we will decide when to start on Gypsy and Koau stations.

- 65 Gormack St

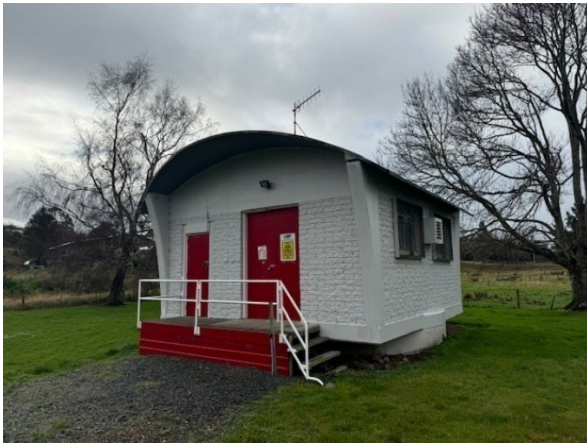
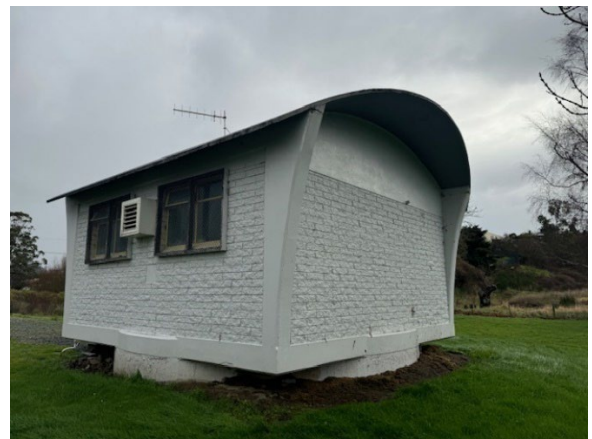
**Gypsy Pump Station**

- Gypsy St. - Hasborough Place, Opposite ORC driveway

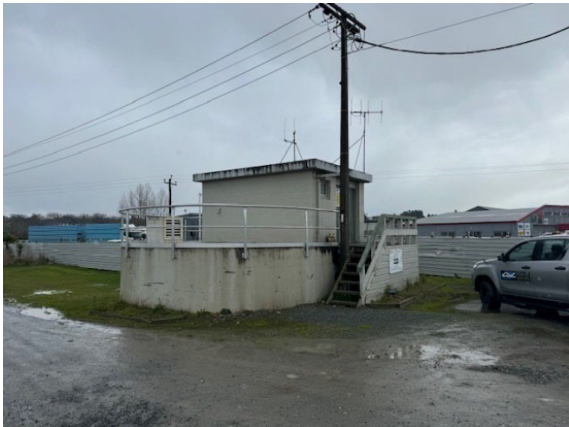
**Koau Pump Station**

- Koau - 2 High Street just before the railway tracks heading to Owaka

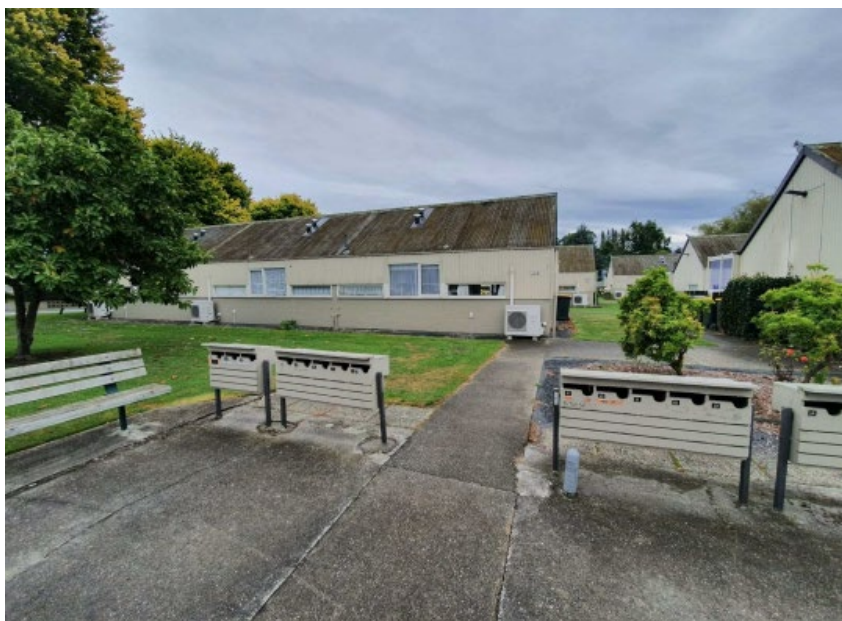
Figure 1. Naish Courts Community Housing Units (64 Charlotte Street, Balclutha)

It is proposed that the replacement of the Windows Installation Programme for Naish Courts Community Housing Units be commenced prior to the major construction work (while waiting for the designs and building consents at the current stage). The reason for this is that some units are currently not compliant with the Healthy Homes Standards as advised by our consultant, Betta Property Compliance. This will bring them up to standard as soon as possible. No design and no building consent is required for this prior project. The contractor can commence the construction during the golden summer period as well. There is adequate funding and resources this 24/25 financial year for the Windows Installation Programme.
